CHAPTER 2

REPORT ON THE 1985 EXCAVATIONS BUILDING 250: A SET OF ANIMAL PENS

Site supervisor: Ann Bomann

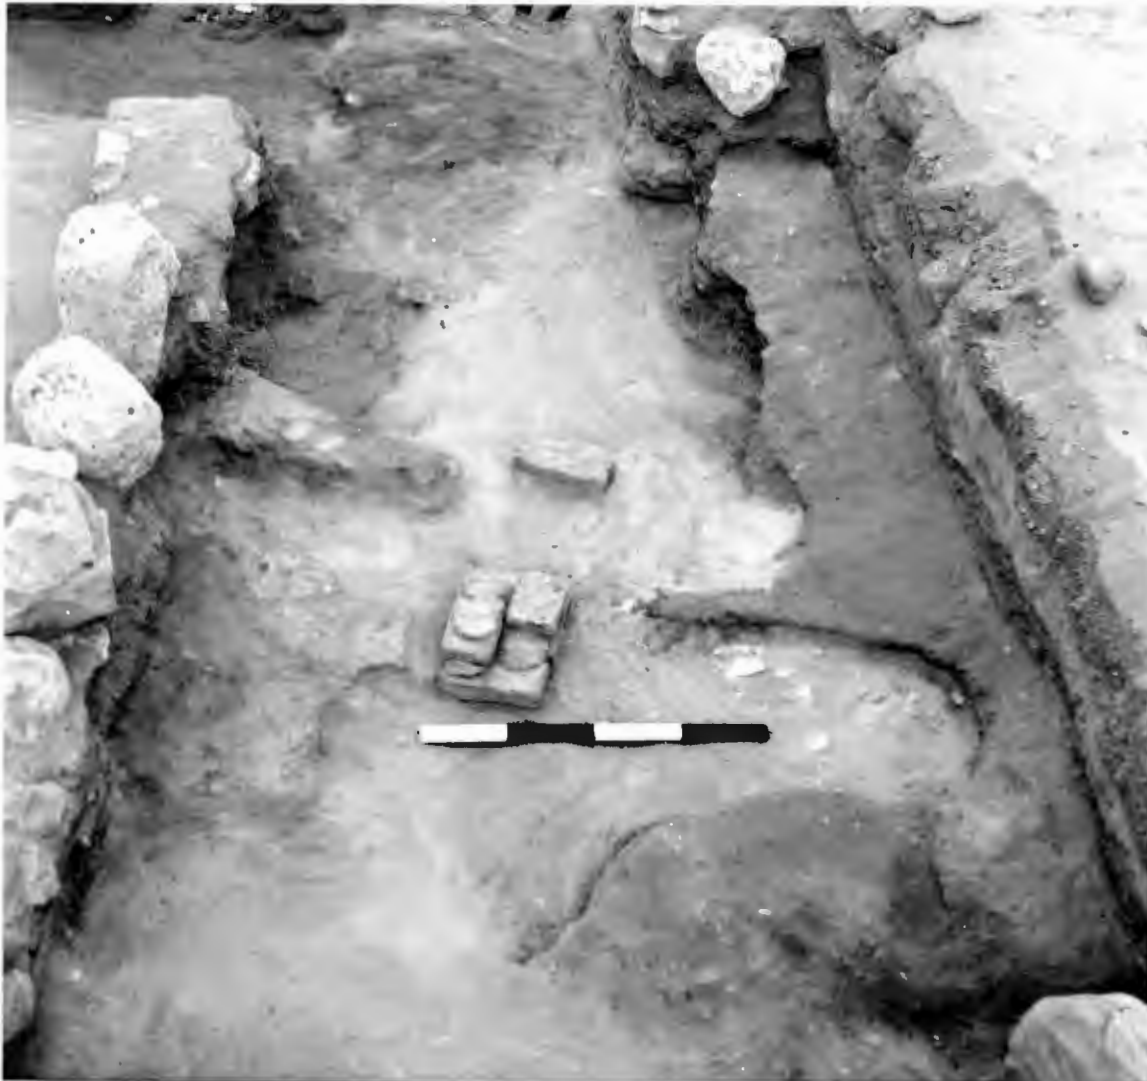
Figure 2.4. Wall fragments [1832] at the lowest level in **Area vi** in square Q26, looking west. The ragged edges of the adjacent dark organic deposits mark the edges of modern robbers' pits.

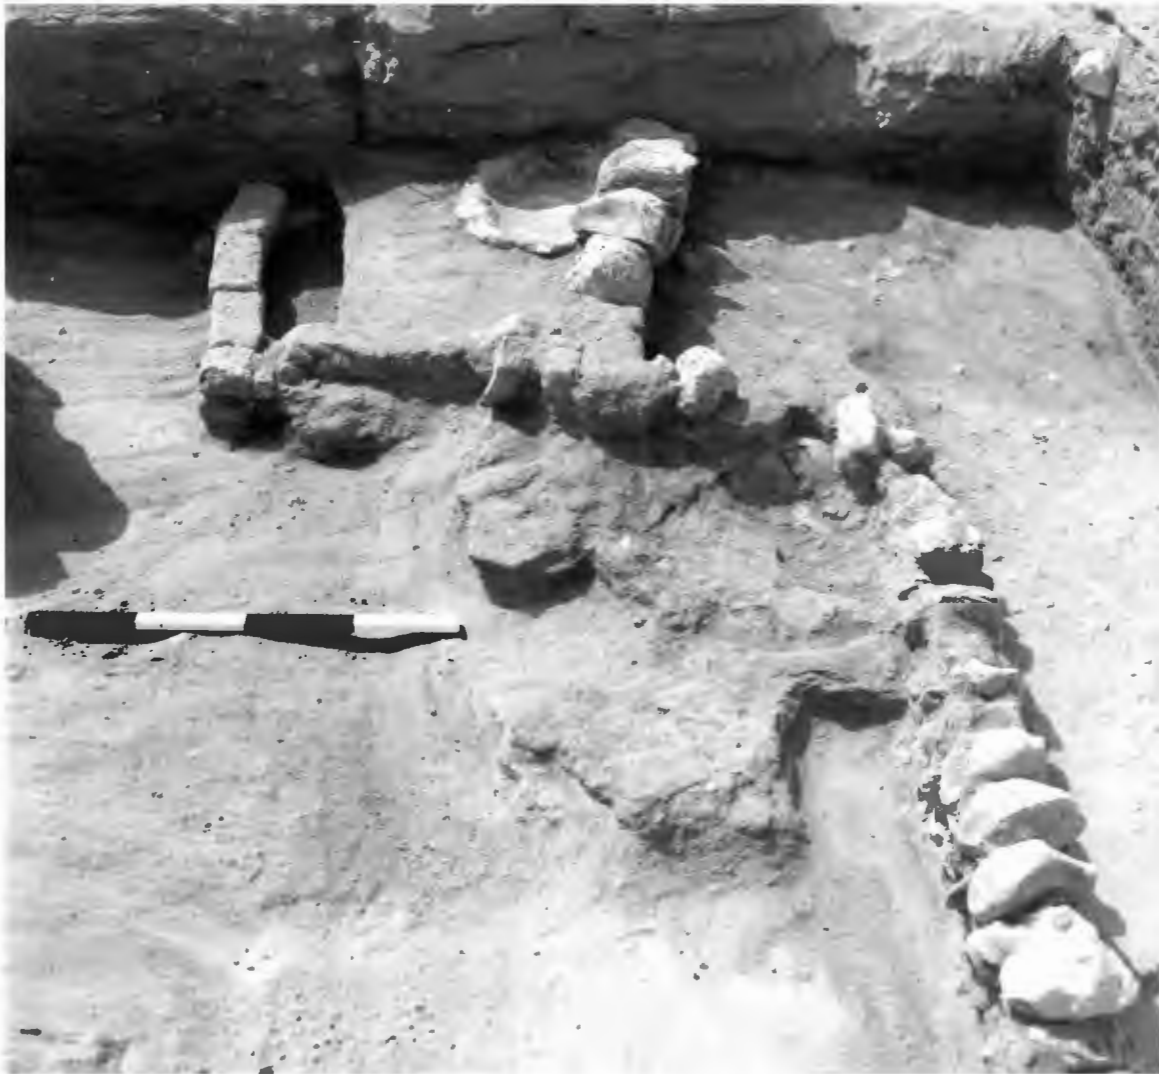
Figure 2.5. **Areas vii - ix** in squares O25 and P25, looking south.

The south side of **Area i** seems to have been partly open to give access to structures now almost wholly destroyed, partly by modern robbing which was particularly intense here and partly as a result of ancient alterations. The most intact part, consisting only of foundation courses, is **Area viii**, partly surrounded by brickwork [1834] (Figure 2.5). As the section (Figure 2.6) shows, this space came to contain an organic fill [1771].

Modern digging had also undermined and removed much of the south wall [1653], although its original position is marked in broken lines on both the plan (Figure 2.1) and section (Figure 2.6). Further south still the first-phase wall [1834] was knocked down and a broader space created which consisted of **Areas viii** and **ix**. Against the new west wall [1889] a trough [1864] was constructed from stones and gypsum (Figure 2.5).

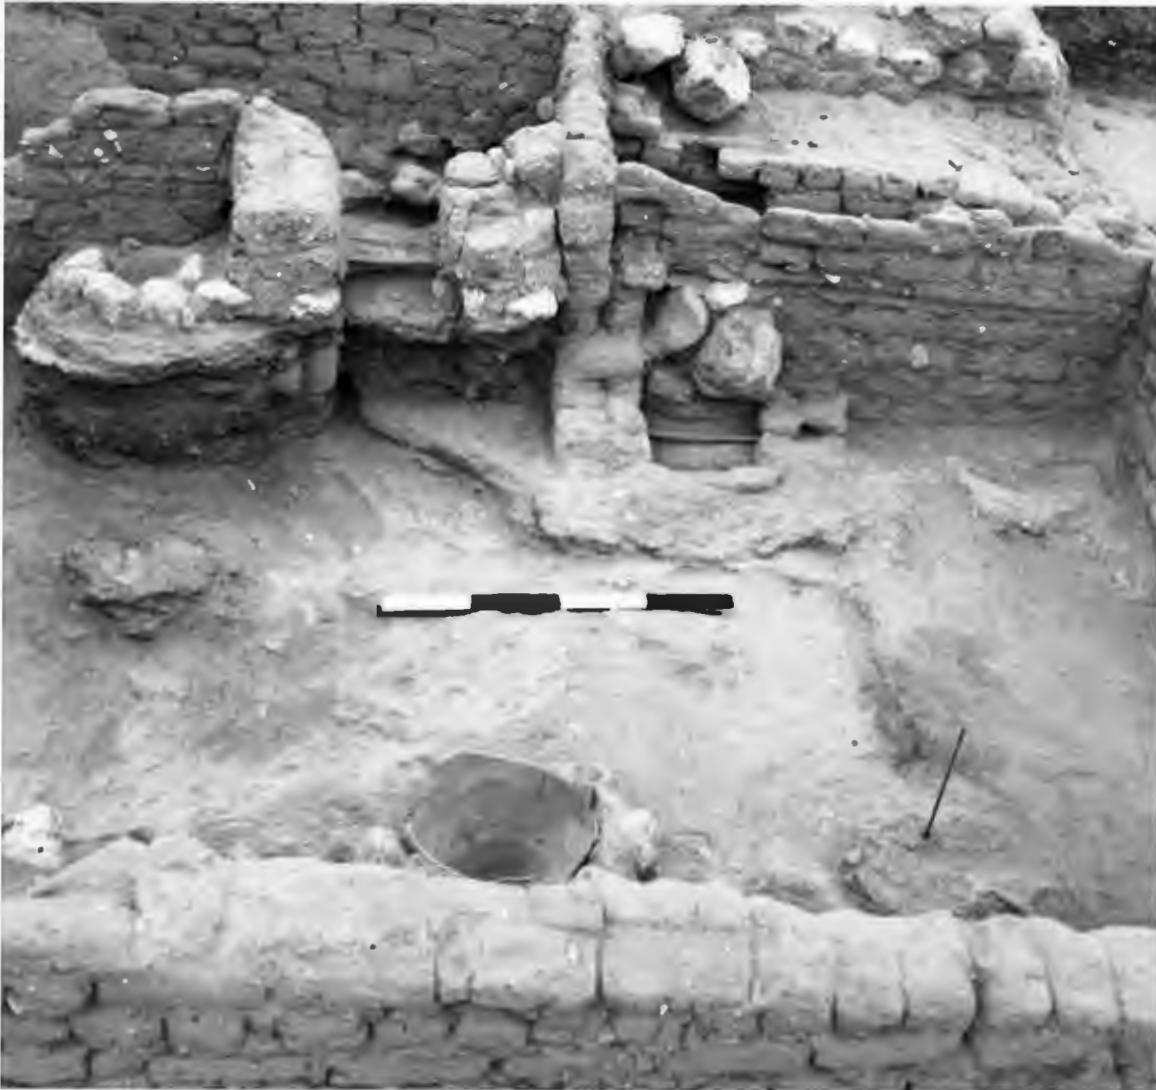
Figure 2.9. The west walls of **Areas ii** and **iii**, looking east. Note the blocked-up doorway into **Area iii** on the south, with the second-stage brickwork above, and the new doorway at higher level into **Area ii** on the north. In the background on the right are the foundations of wall [1660] and bricks and stones from the doorway [1378]. The lowest wall [1905] which subdivides **Area i** had not yet been exposed.

The same section shows dramatically the subsequent history of the building. Both inside it and outside organic rubbish accumulated, gradually burying the various walls until a decision was made to reconstruct at a higher level. The reconstruction was, however, only partial. In the case of wall [1376] the doorway was blocked up. As the photograph (Figure 2.9) shows, the height of

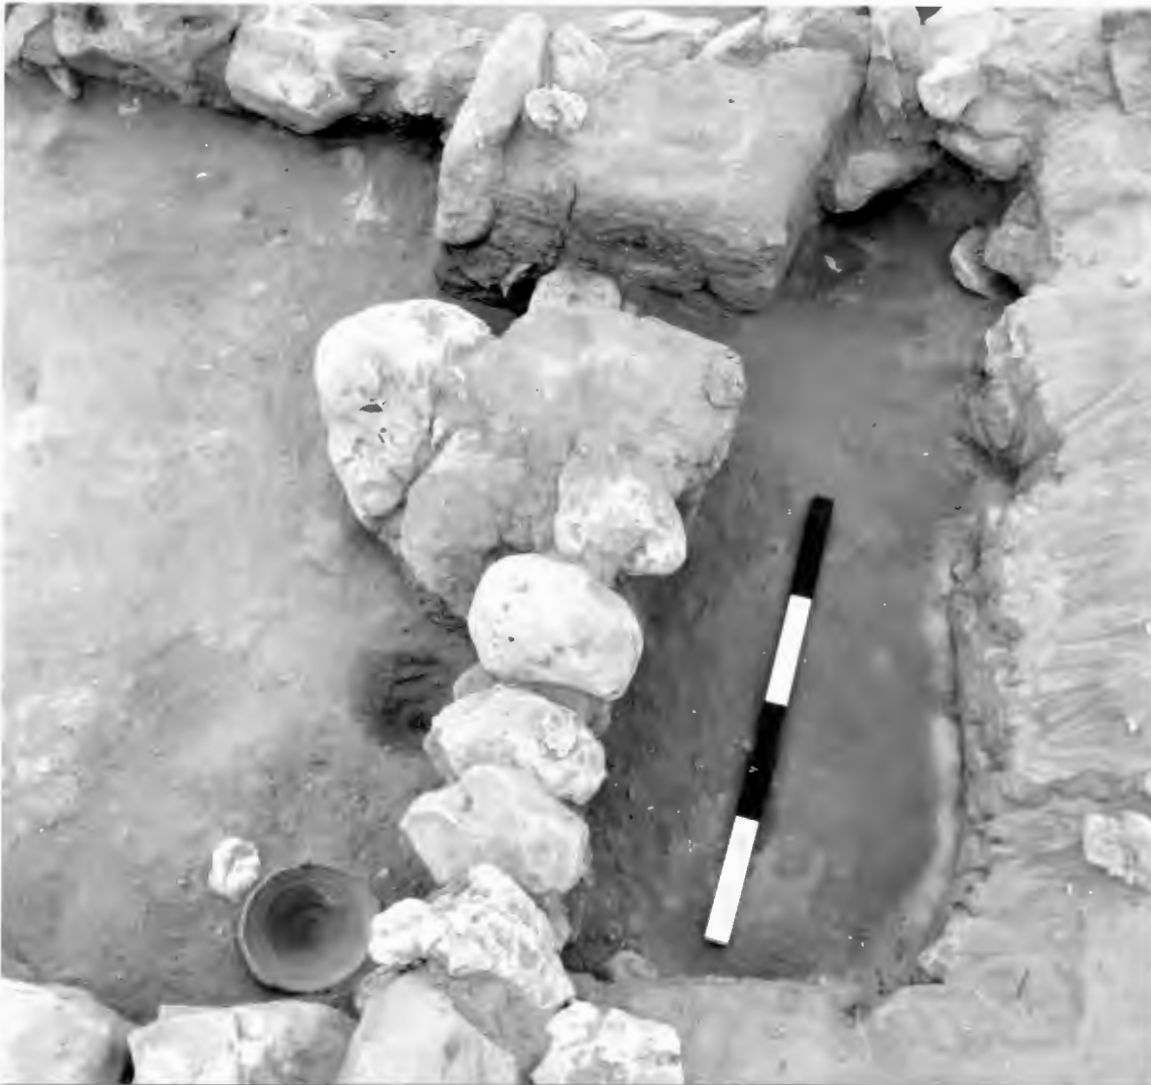
Figure 2.10. **Areas v** and **x** in square Q26, looking north, with organic floor deposit [1901] still in place.

This phase also saw the construction of at least two new sets of pens. One occupies the southern part of square Q26 (Figure 2.10). **Area v** is the outer court, bounded on the north by wall [1795]. At the west end deep modern trenching has destroyed everything down as far as natural desert, so that it is not known if this wall joined the rear wall of **Area ii** directly, or turned southwards roughly along the line of division between squares Q26 and P26. The
