## CHAPTER 3

REPORT ON THE 1986 EXCAVATIONS  
WORK INSIDE THE WALLED VILLAGE (2): GATE STREET 9

Site supervisor: Angela M.J. Tooley

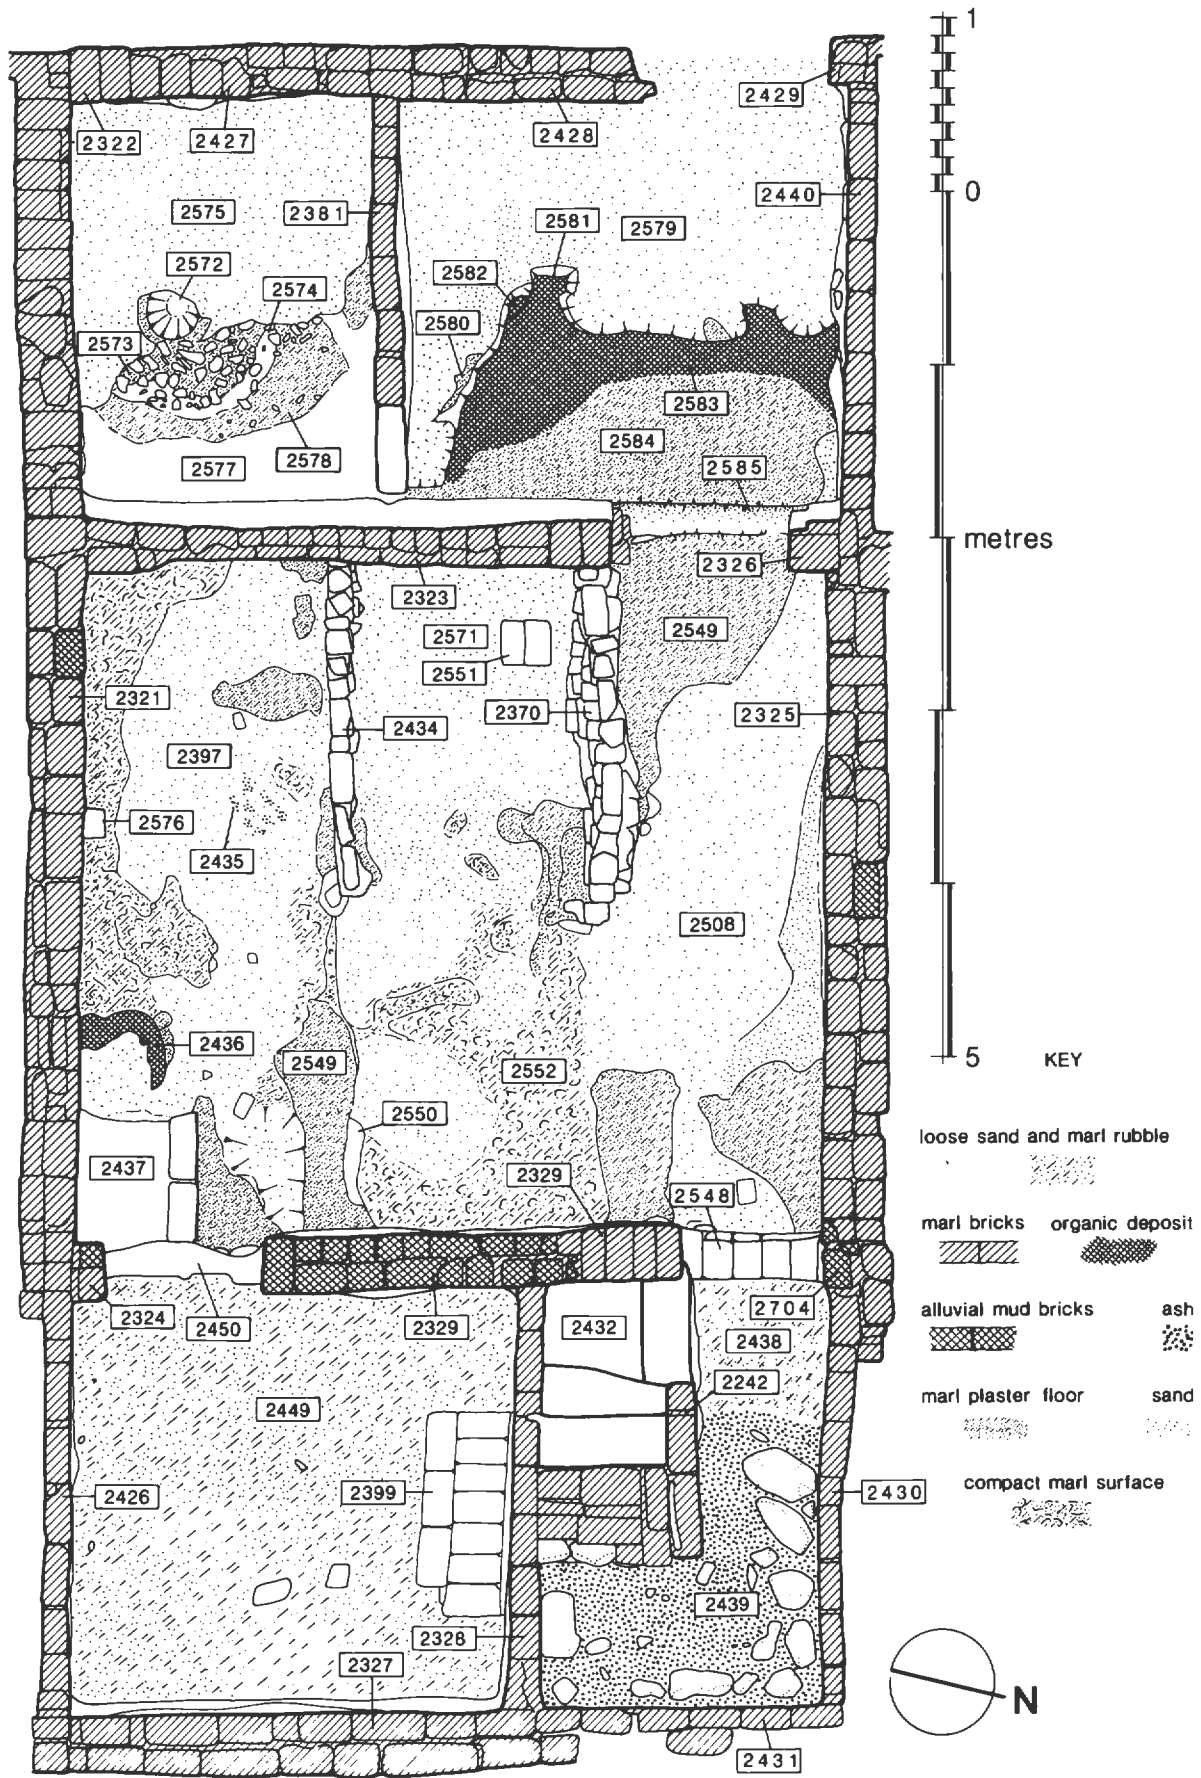
Figure 3.1. Plan of the house Gate Street No. 9 (original by Angela Tooley).

The same labelling system and order of description will be followed as was used for Gate Street 8 (AR III: 3; and see this volume, Figure 3.1).

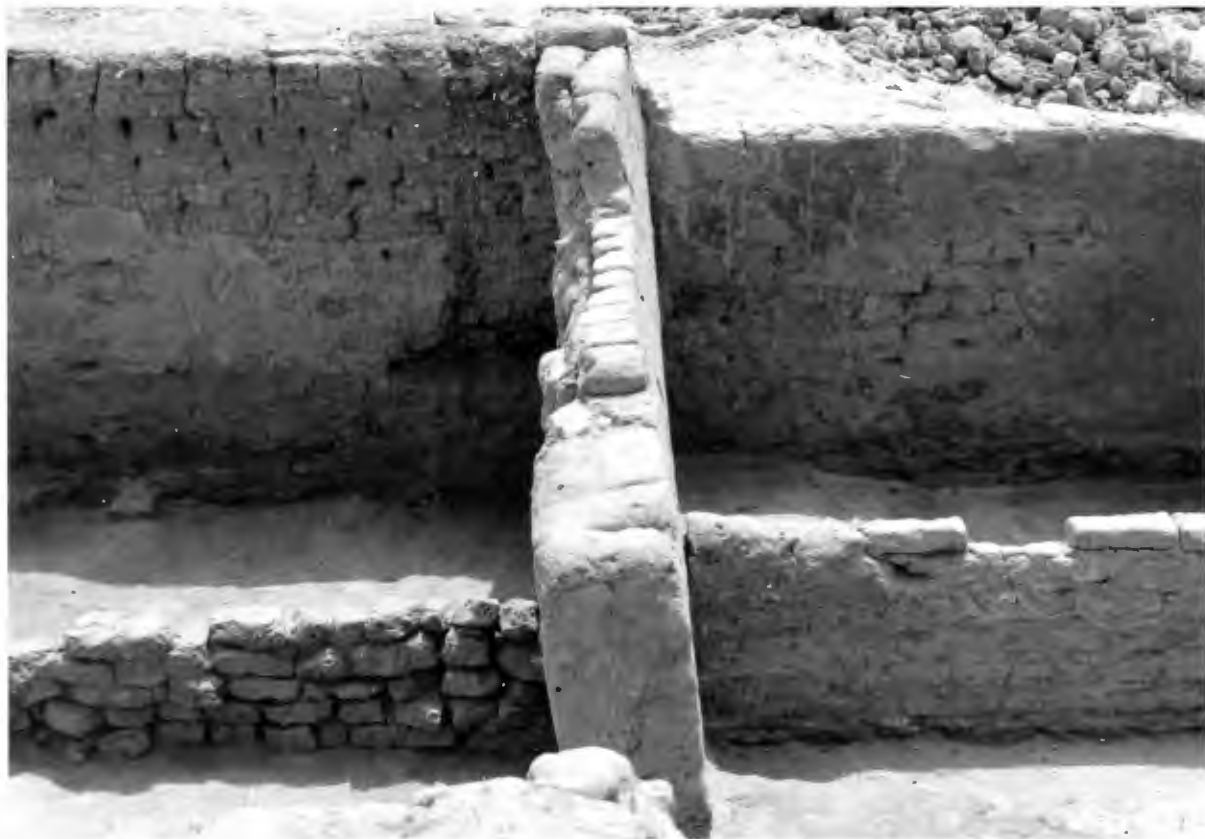
Figure 3.2. The dividing wall between the Front and Middle Rooms, looking south and showing the batter. Note the dividing wall in the Front Room with rounded top at the left end (original access ?), and the rubble wall in the Middle Room.

The two Front Rooms had been separated by a partition wall [2233], originally about one metre in height (although the uppermost bricks had been lost to modern robbing; Figures 3.2, 3.5). It was presumably added after the change in the position of the front door, for it contained no proper doorway of its own, but at the east end a short length of wall 65 cms. above the floor had a smoothly worn surface and probably therefore marked the place by which access was gained, by climbing over. This was not a unique arrangement, for several houses dug in the 1920s had protected their mortars and/or quern emplacements by screen walls not provided with proper

The other factor is the inward slope of the west wall (Figures 3.2, 3.5). It was not possible to determine, without partial demolition, to what extent the west wall was keyed into the south wall. The junction had, however, remained firm for there was no sign of serious cracking or slipping of brickwork. As the front elevation shows, the north and south walls of the house (which were also north and south walls respectively of Gate Street 8 and 10) leaned inwards, squeezing wall [2323] between them. If we wish to add an upper room over the Middle Room we have to envisage this sloping wall continued upwards for a further 1.80 metres or so. Towards the top the entire thickness of the wall would have been outside the line of its foundations at the bottom. At the current top of the south side wall of the house, where it meets this west wall, a patch of alluvial mud bricks has been inserted. One could interpret this as the beginnings of extra strengthening, perhaps involving timber ties, to stop the upward continuation of the west wall from collapsing inwards. This has to remain, however, speculative, although one has the impression that if there was no upper storey to Gate Street 9, the outward slope of the north wall of Gate Street 8 could have been a threat to the stability of both houses.

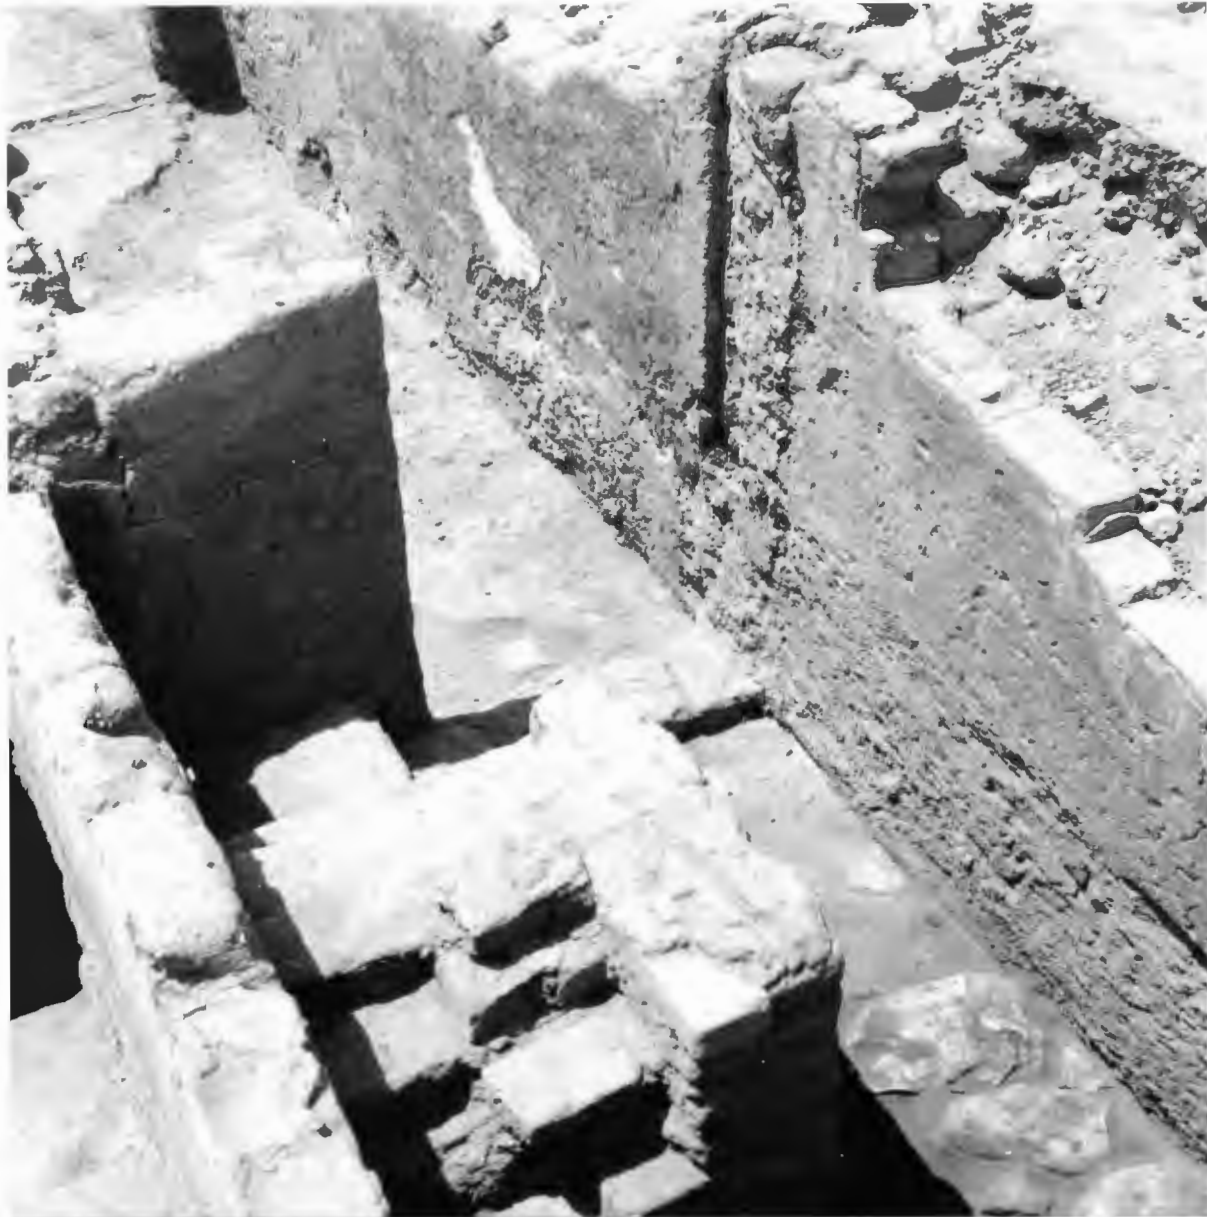
Figure 3.4. The doorway between Rear Room North (with staircase) and the Middle Room, looking north-west. Note the beginning of an inward curve at the top of the right-hand door jamb.

**Rear Room North** (c. 2.48 x 1.60 metres; Figure 3.4): the existence of a staircase had made robbery more difficult, to the extent that it seems to have been confined to the area of the steps and a small deep pit behind the supporting pillar. Otherwise the fill units and much of the floor remained intact. The staircase differed in its arrangement from that in Gate Street 8, on account of the reversal of the roles of the two rear rooms: in no. 8 the staircase occupied the larger room, whereas here it lay in the smaller. A brick pier [2242] had been built out from the dividing wall [2328], and the steps [2432] had been built to fill the space between it and the west wall [2329]. Four steps had been preserved, in a right-angled configuration. Alluvial mud bricks had been used

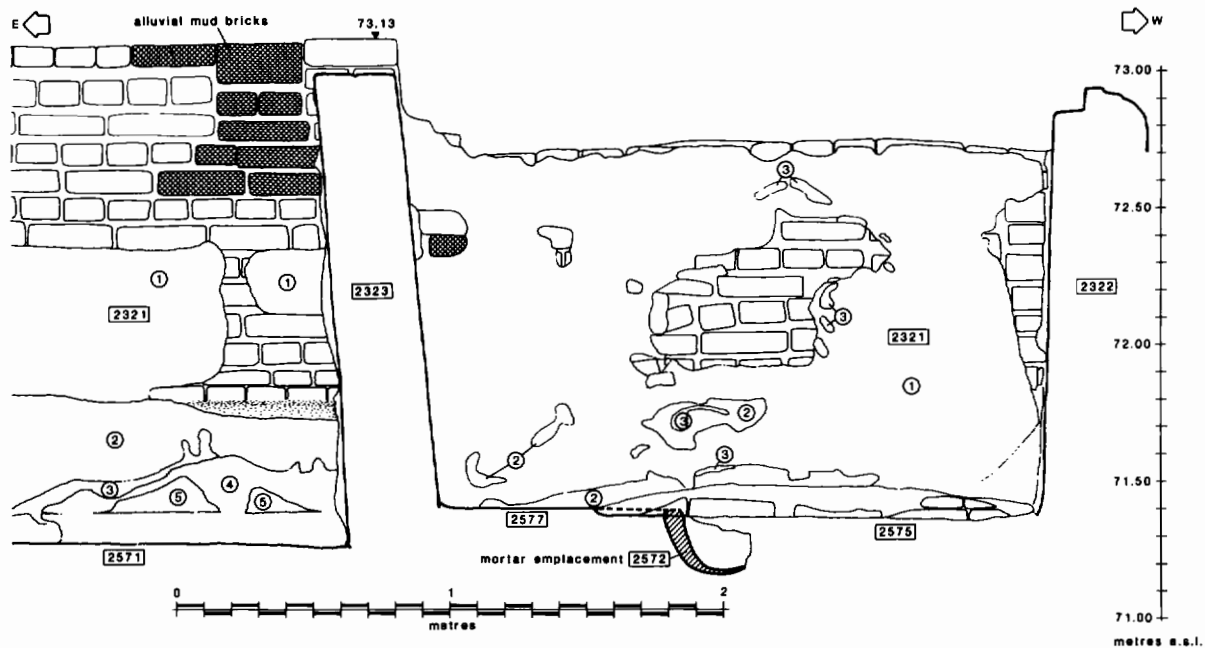
Figure 3.5. Elevation of the south wall of Gate Street 9, with section through the dividing wall between Front and Middle Rooms (original by Angela Tooley).

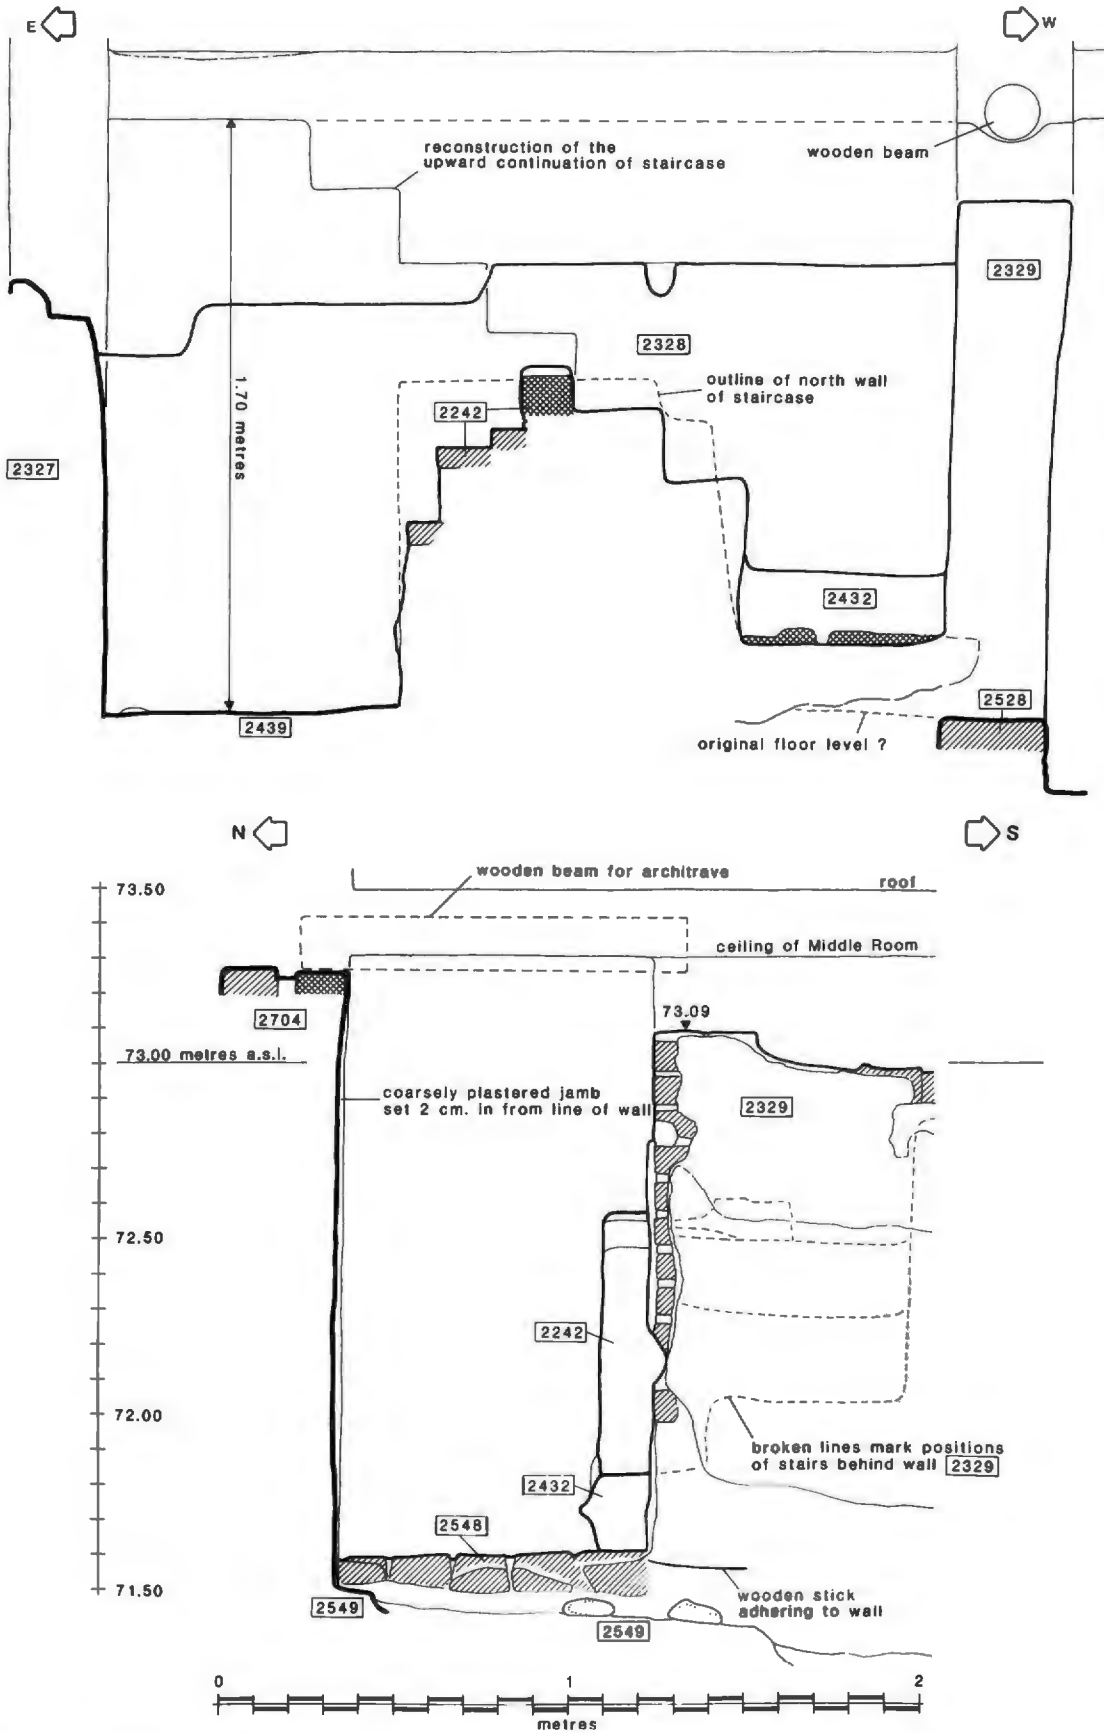
Figure 3.6. Elevations of the staircase of Gate Street 9 (originals by Angela Tooley).

in their construction (Figure 3.6). As in no. 8, the steps would have continued southwards towards the rear of the house, leaving a small cupboard underneath. The brickwork around the top of the pier had been damaged so that nothing remained of the supports which carried the stairs over the cupboard. One piece of squared-off wood did, however, remain lying across the top of the pier. Removal of the rubble fill, partly loose material from modern digging [2077, 2229, 2248, 2343, 2546, and probably 2438] and more compacted rubble [2383, 2386, 2395], exposed a floor of large stones set in marl mortar [2439] bearing a coating of ash.

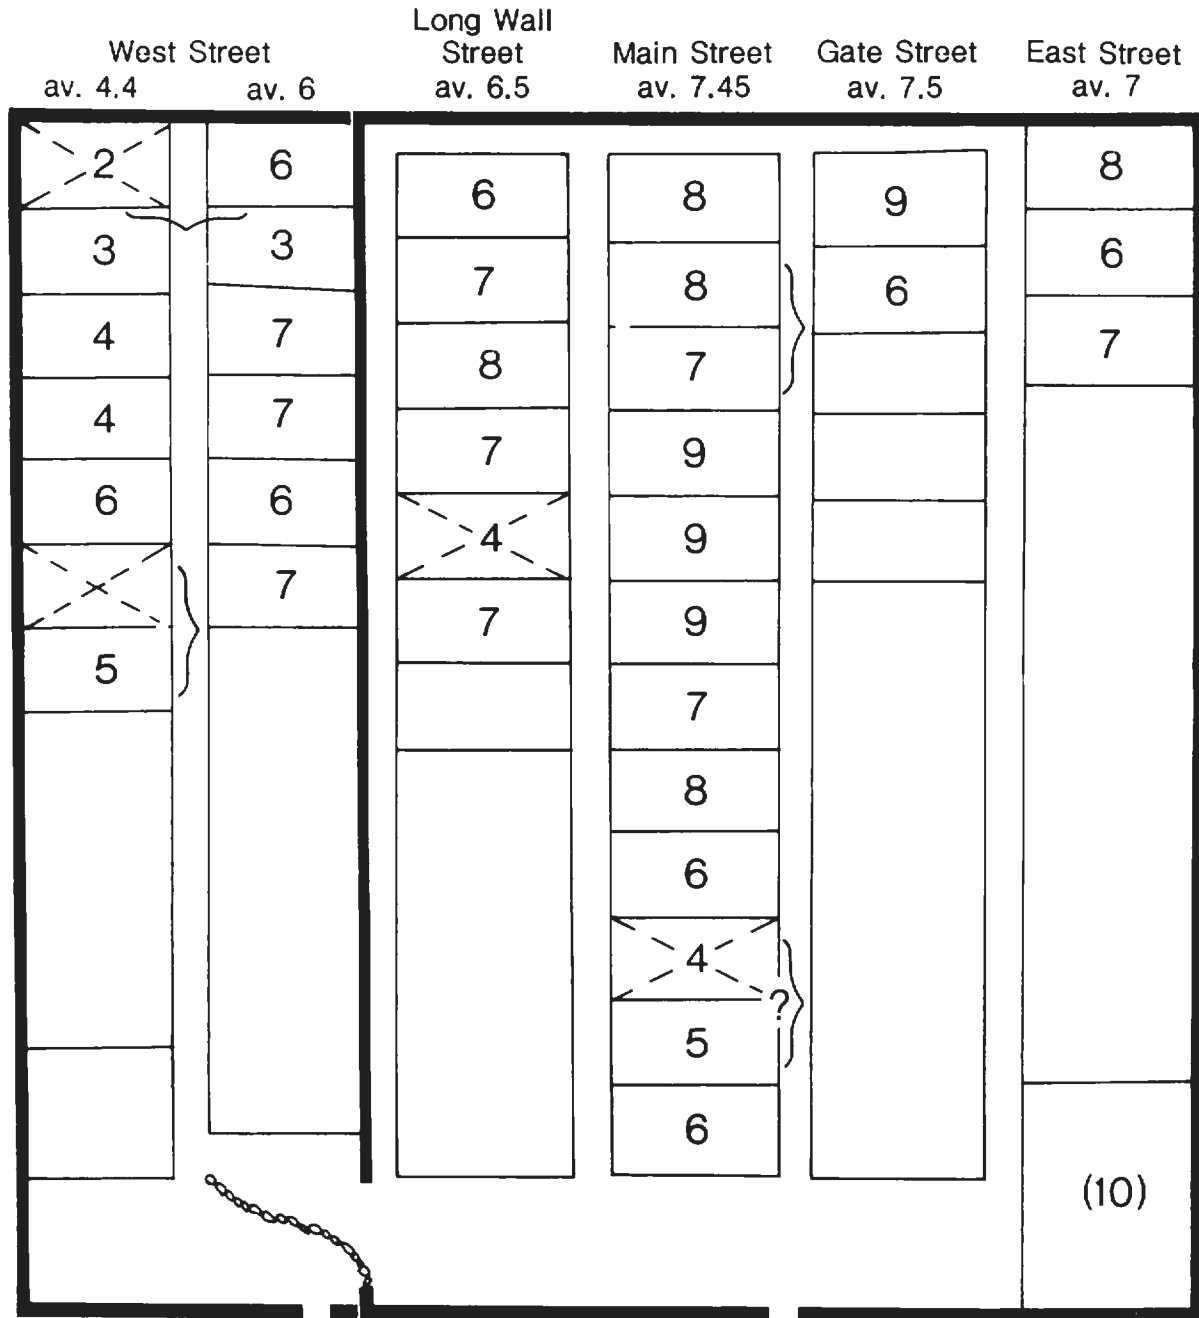
numbers represent scores in terms of structural features present

bracketed pairs of houses indicate possible single enlarged properties

'crossed' houses were probably not normal residences

Figure 3.7. Outline plan of the Walled Village. The numbers are scores based on the presence of structural features, as follows: stairs to roof from rear of house; stairs from Middle Room (two points); shelf supports in rear room; north-south partition walls two bricks in thickness; bed alcove; wall painting; painted plaster in fill; manger; loom-beam socket; stone bath; quern emplacement; mortar; hearth; bench; column base; limestone cavetto cornice. Because of disturbance and robbery subsequent to 1922 no scores are given for the four houses newly excavated.
