CHAPTER 3

REPORT ON THE 1986 EXCAVATIONS
WORK INSIDE THE WALLED VILLAGE (2): GATE STREET 9

3.1 The house Gate Street no. 9: basic features

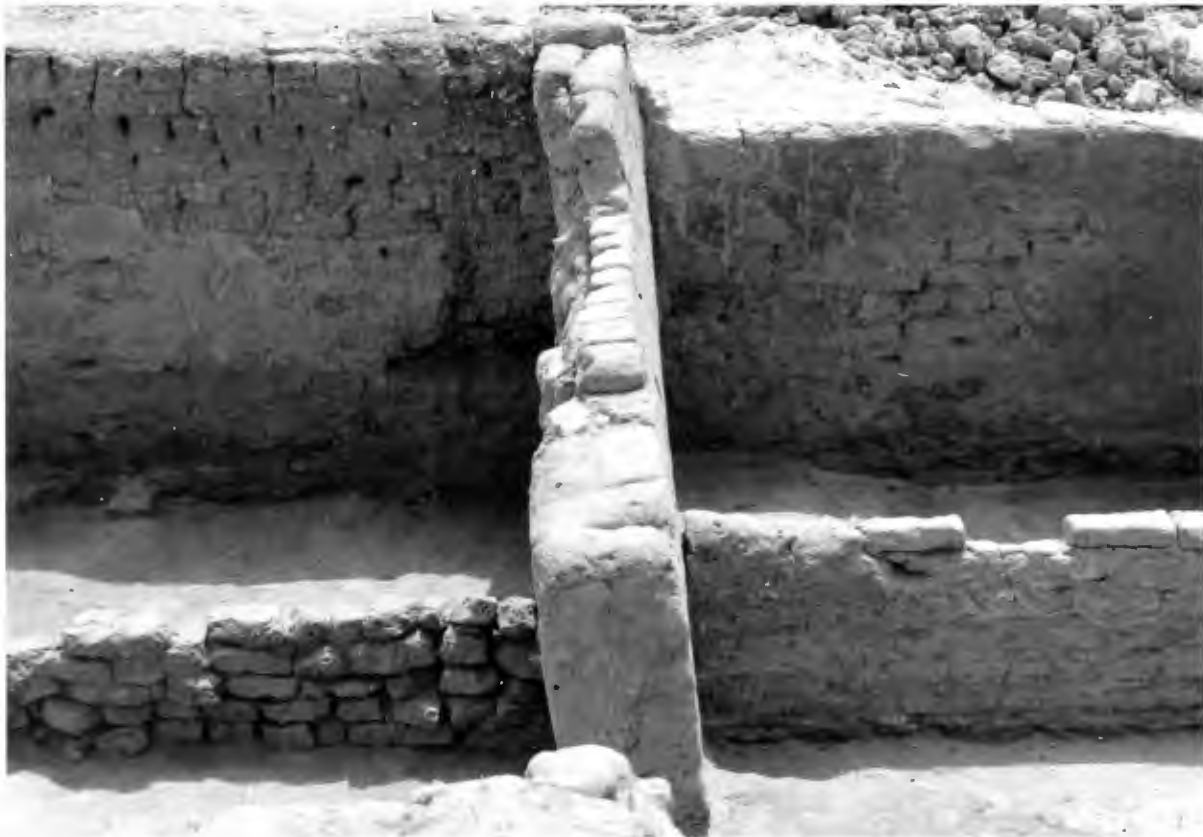
Figure 3.2. The dividing wall between the Front and Middle Rooms, looking south and showing the batter. Note the dividing wall in the Front Room with rounded top at the left end (original access ?), and the rubble wall in the Middle Room.

The two Front Rooms had been separated by a partition wall [2233], originally about one metre in height (although the uppermost bricks had been lost to modern robbing; Figures 3.2, 3.5). It was presumably added after the change in the position of the front door, for it contained no proper doorway of its own, but at the east end a short length of wall 65 cms. above the floor had a smoothly worn surface and probably therefore marked the place by which access was gained, by climbing over. This was not a unique arrangement, for several houses dug in the 1920s had protected their mortars and/or quern emplacements by screen walls not provided with proper

The other factor is the inward slope of the west wall (Figures 3.2, 3.5). It was not possible to determine, without partial demolition, to what extent the west wall was keyed into the south wall. The junction had, however, remained firm for there was no sign of serious cracking or slipping of brickwork. As the front elevation shows, the north and south walls of the house (which were also north and south walls respectively of Gate Street 8 and 10) leaned inwards, squeezing wall [2323] between them. If we wish to add an upper room over the Middle Room we have to envisage this sloping wall continued upwards for a further 1.80 metres or so. Towards the top the entire thickness of the wall would have been outside the line of its foundations at the bottom. At the current top of the south side wall of the house, where it meets this west wall, a patch of alluvial mud bricks has been inserted. One could interpret this as the beginnings of extra strengthening, perhaps involving timber ties, to stop the upward continuation of the west wall from collapsing inwards. This has to remain, however, speculative, although one has the impression that if there was no upper storey to Gate Street 9, the outward slope of the north wall of Gate Street 8 could have been a threat to the stability of both houses.
