CHAPTER 4

REPORT ON THE 1986 EXCAVATIONS
BUILDING 200: ANIMAL PENS AND PLANT BEDS

Site supervisor: Ann Bomann

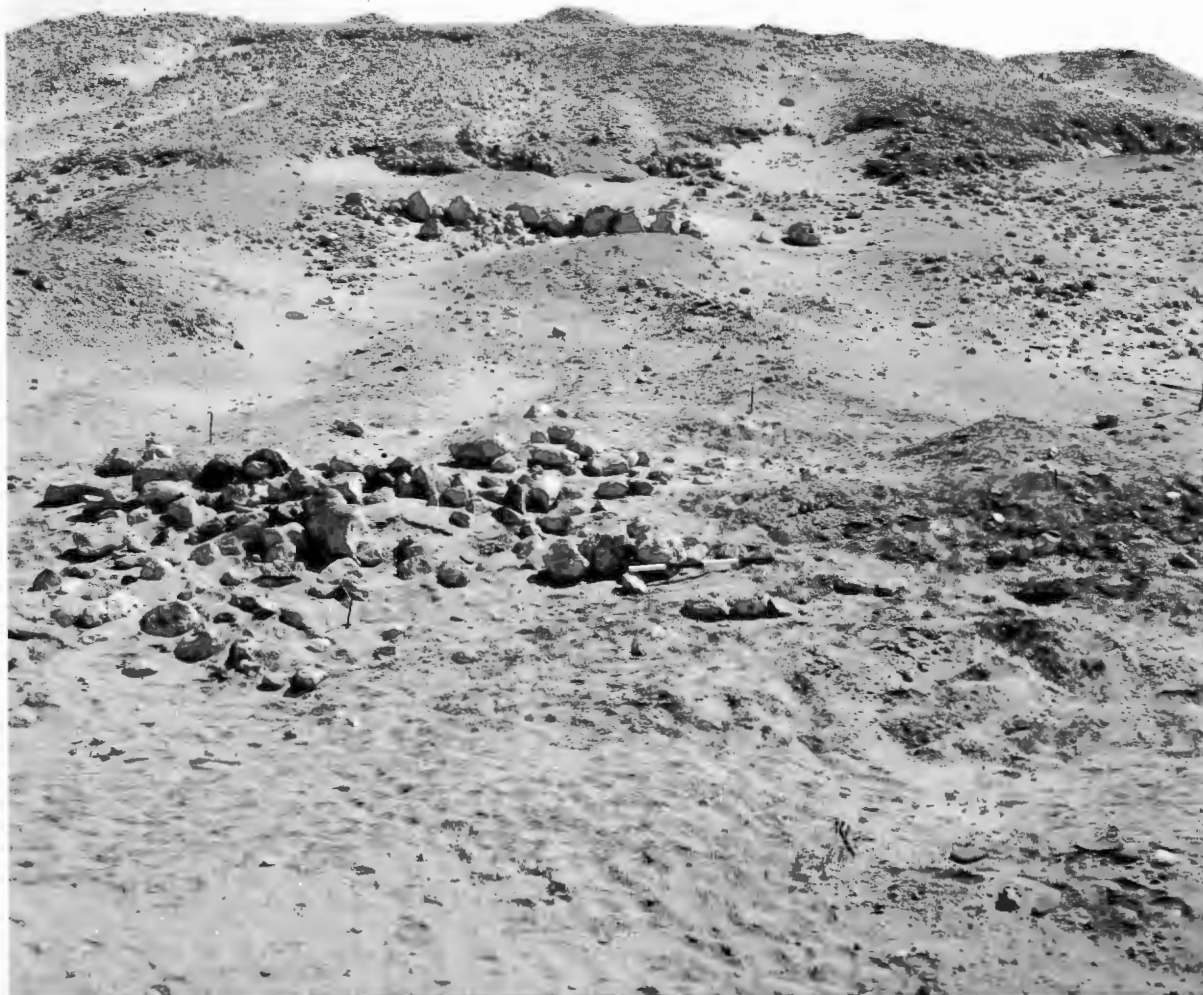
Figure 4.1. View of the site before excavation, looking east. Most of the boulders lie in square T28. On the hillside above the line of stones probably marks a court in front of a tomb entrance (no. 557).

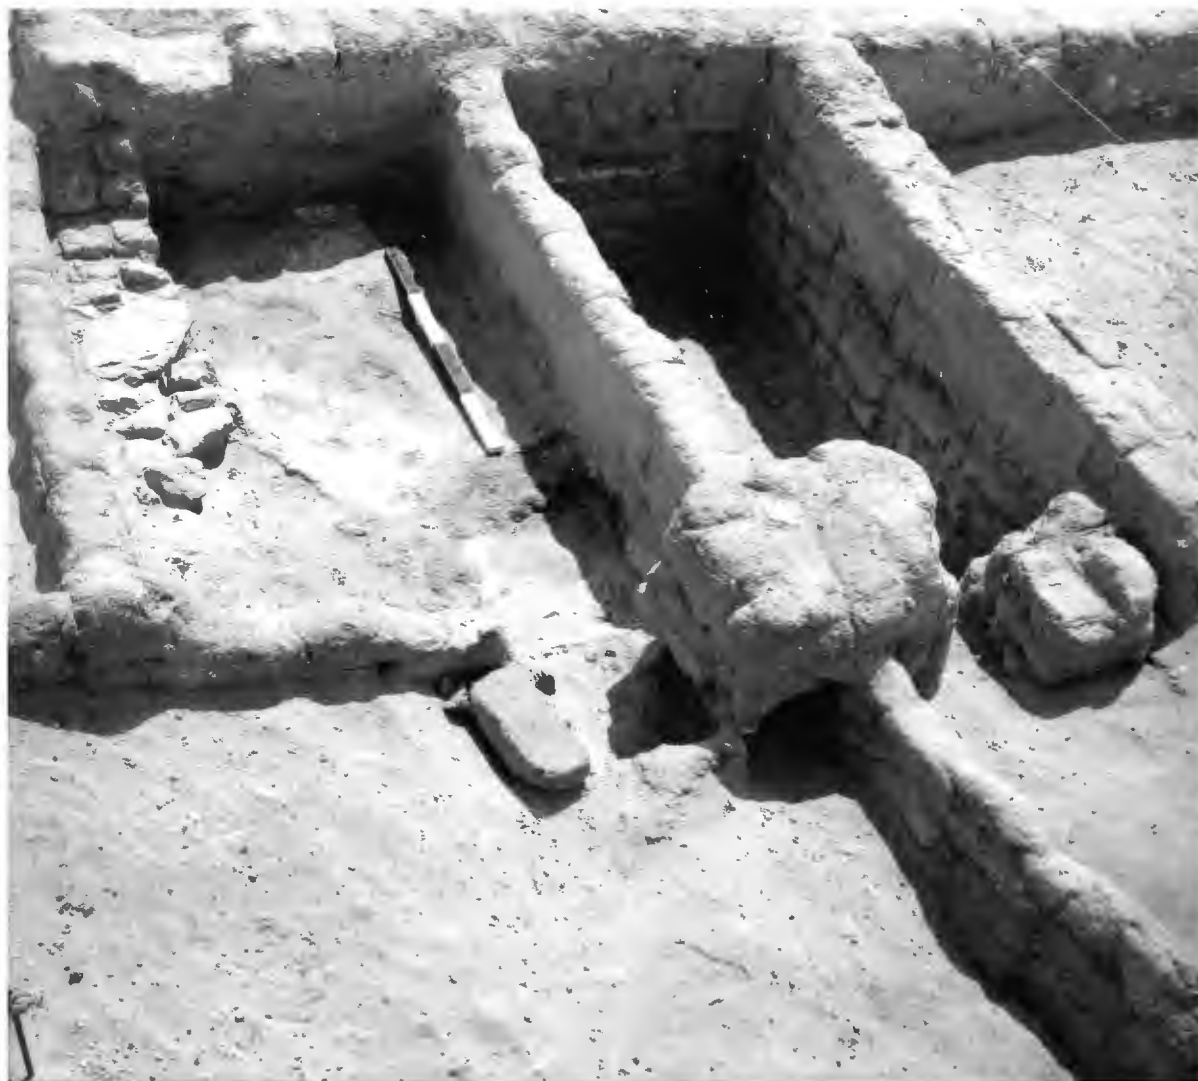
Figure 4.3. Areas ii and iii, looking south.

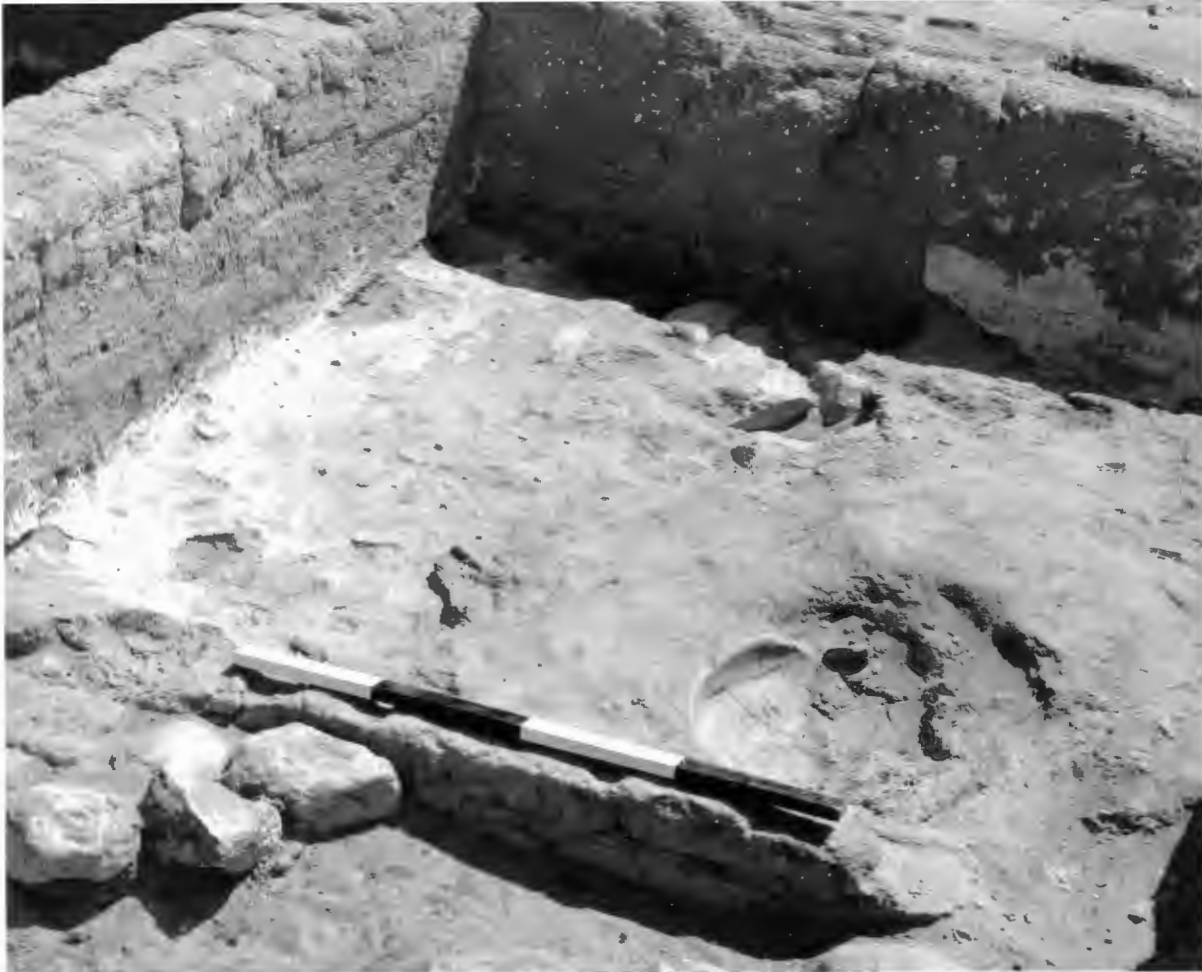
Figure 4.4. Area i, looking south-east. Note the gypsum floor and sunken pottery bowl.

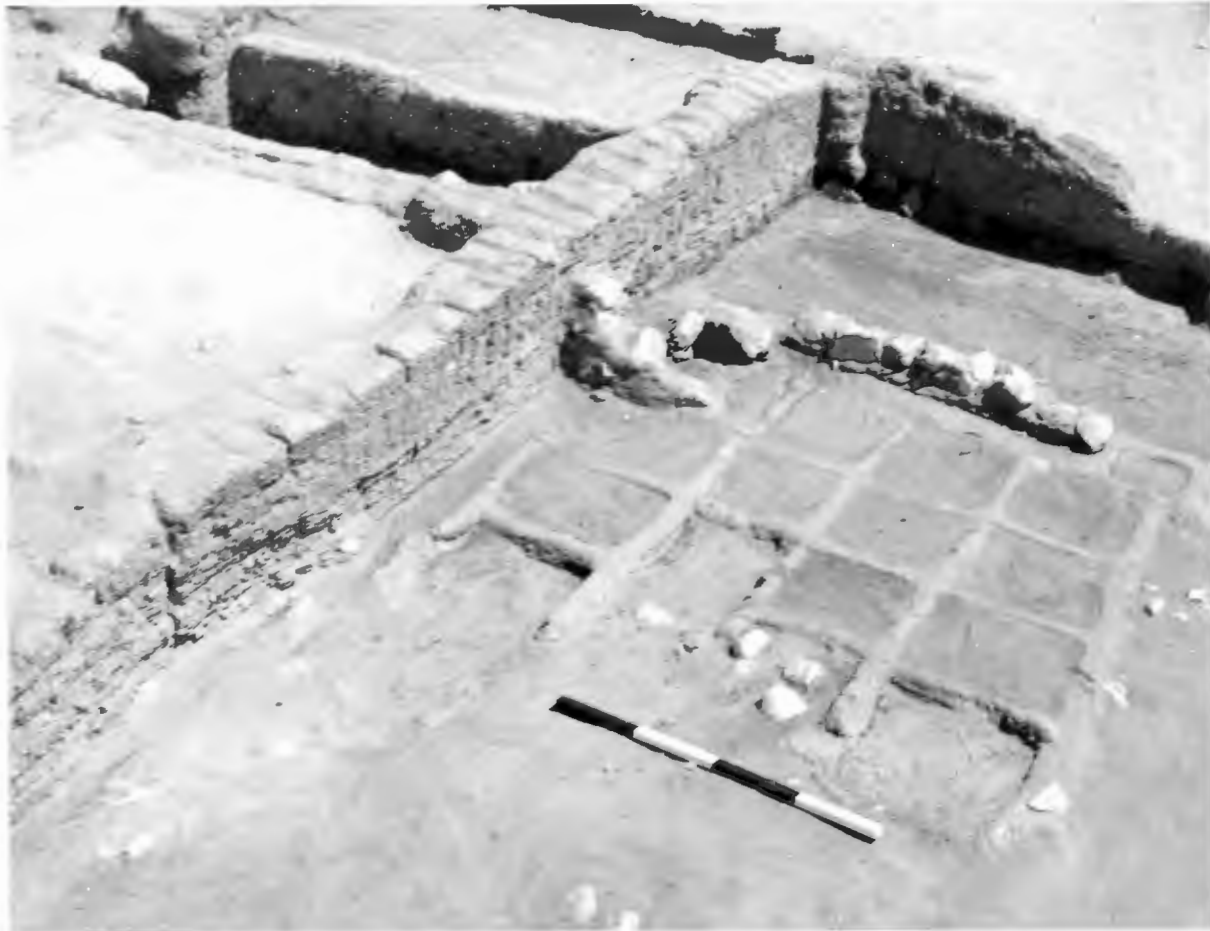
Figure 4.5. View of the garden plots at an early stage of excavation, looking east. Note the rough stone wall [2347] running along the back of the plots.

soil. Some irregular additions had been made on the east, which had subsequently been covered by a low stone wall [2347] (not shown in Figure 4.2, but visible in Figure 4.5). On the west, modern disturbance has exposed the outline of an original low enclosure wall [2537]. This shows that originally twenty of these plots were laid out, in five rows of four (ignoring in the count the double-sized plot in the middle).

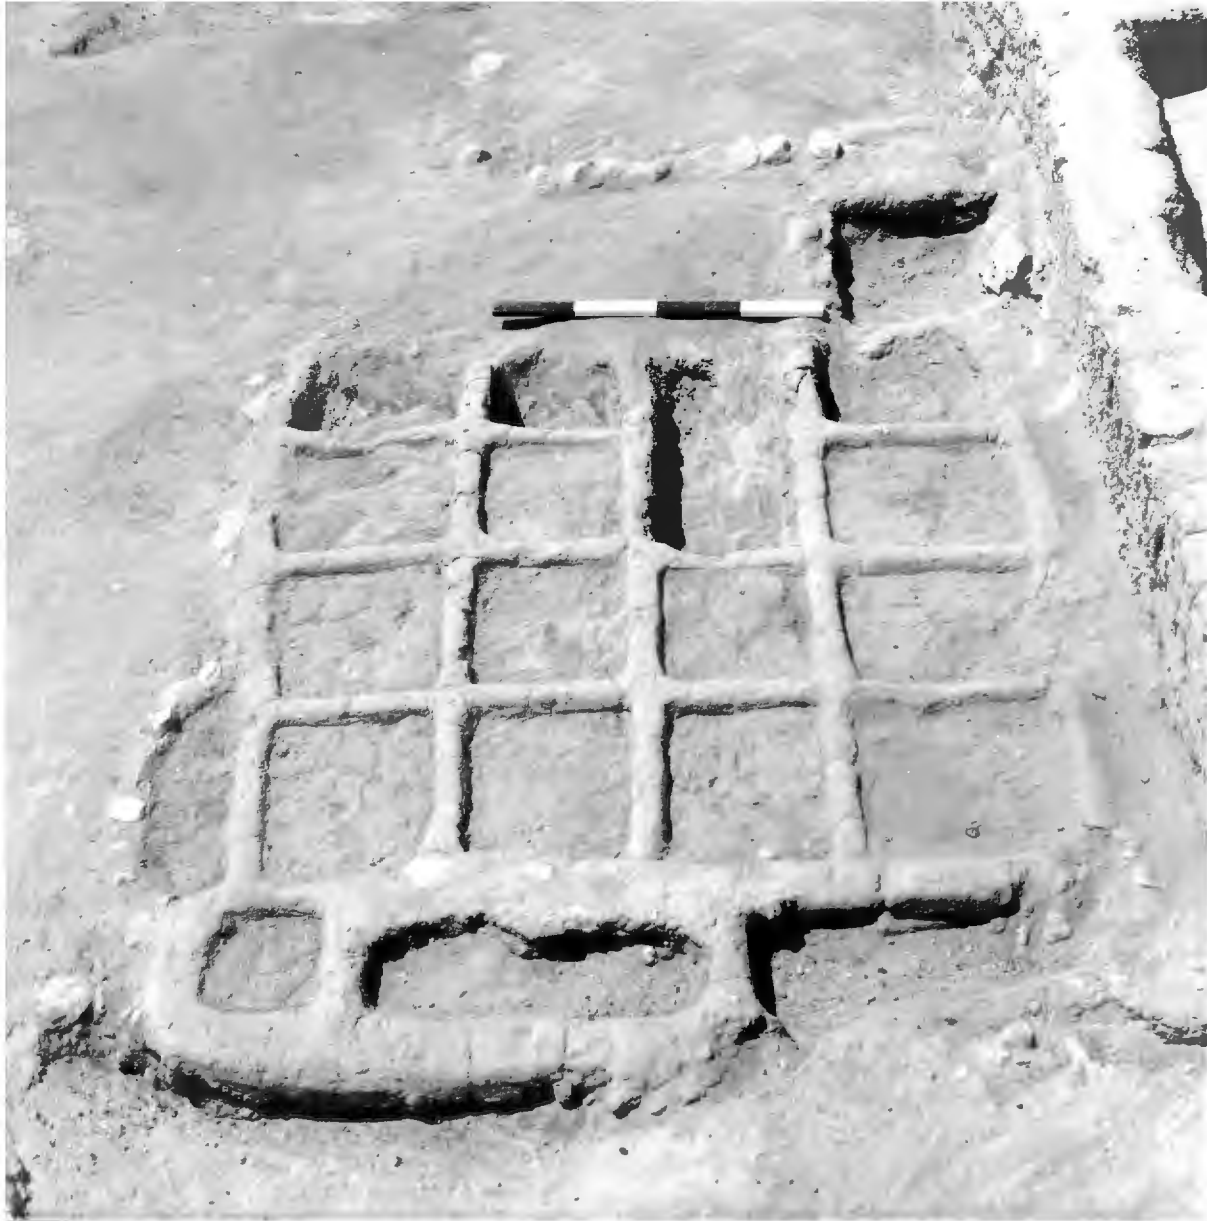
Figure 4.6. The garden plots, looking west, near the end of the excavation.
