CHAPTER 8

REPORT ON THE 1986 AMARNA SURVEY

8.2 The Sanctuary of the Great Aten Temple by Barry J. Kemp

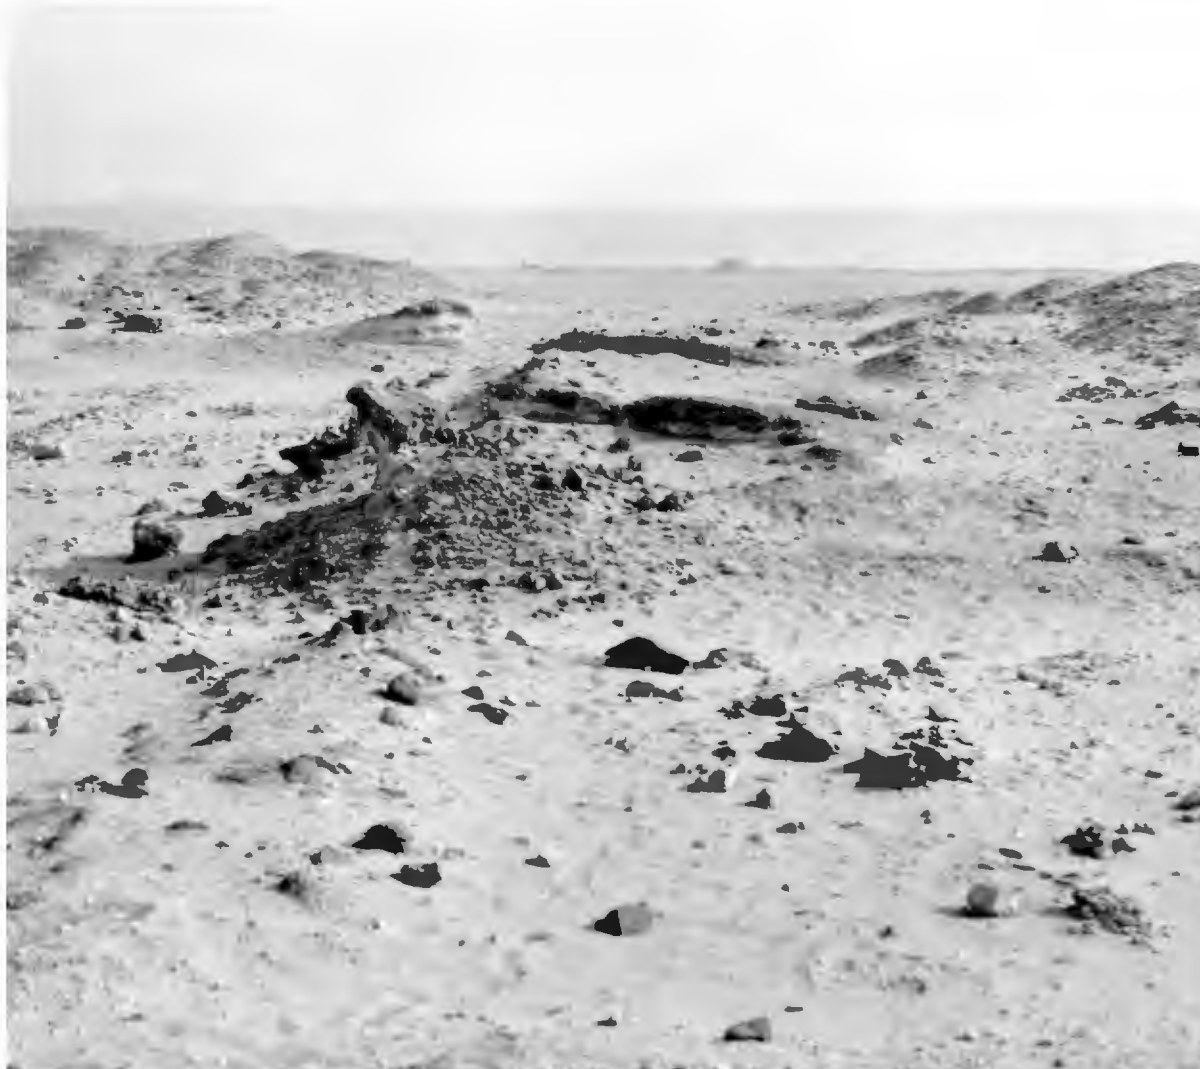
Figure 8.2. Remains of the embankment along the rear of the Sanctuary, looking north.

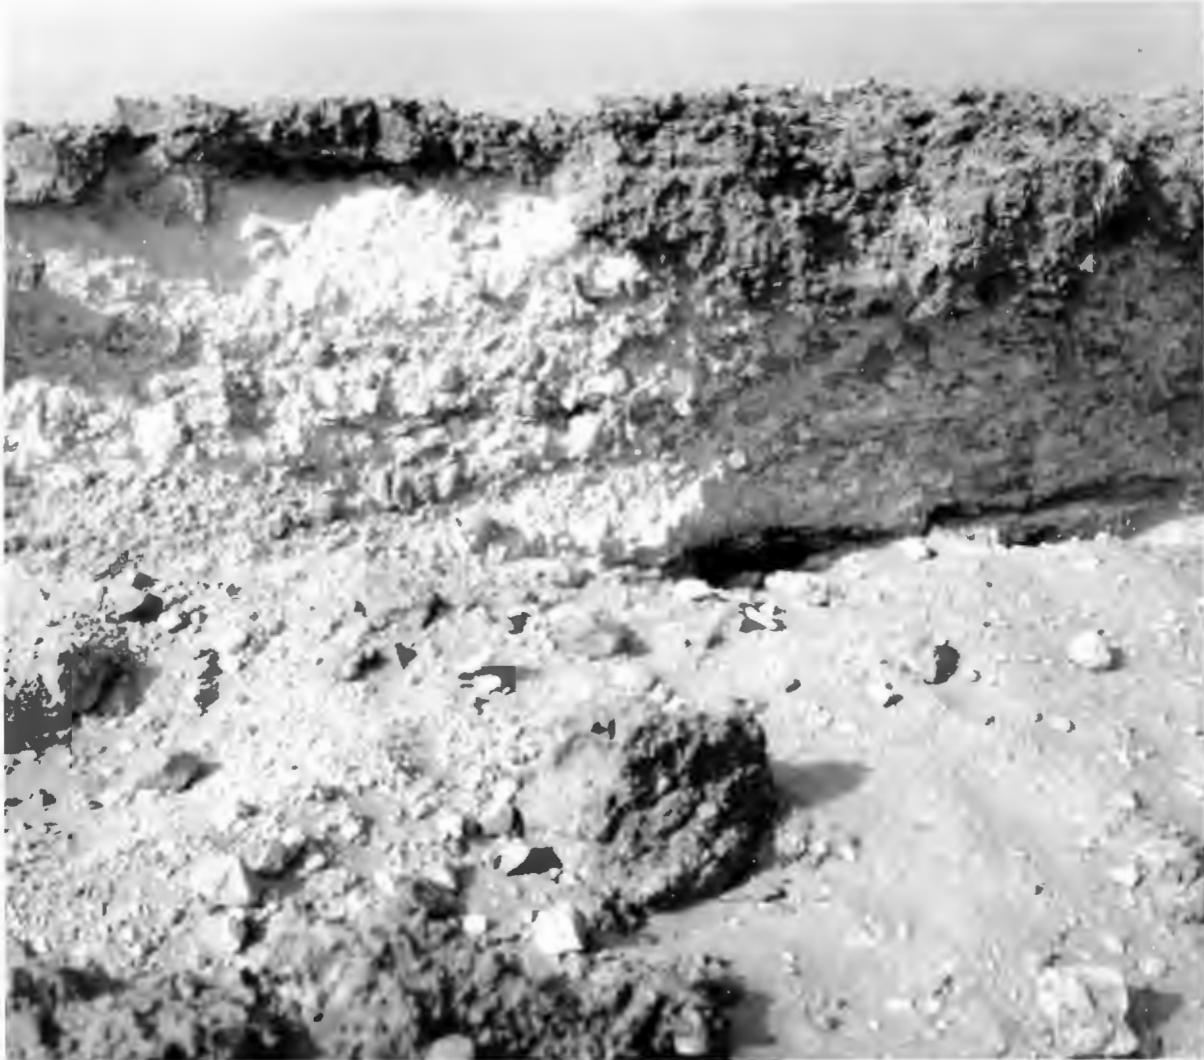
Figure 8.5. Detail of the embankment on the south side, showing the darkened weathering crust that has formed on the top of the gypsum concrete, and the horizontal division lower down between the base of the concrete and the top of the natural desert.
