CHAPTER 3

REPORT ON THE 1983 EXCAVATIONS CHAPELS 570 AND 571

Site supervisor: Christopher Hulin

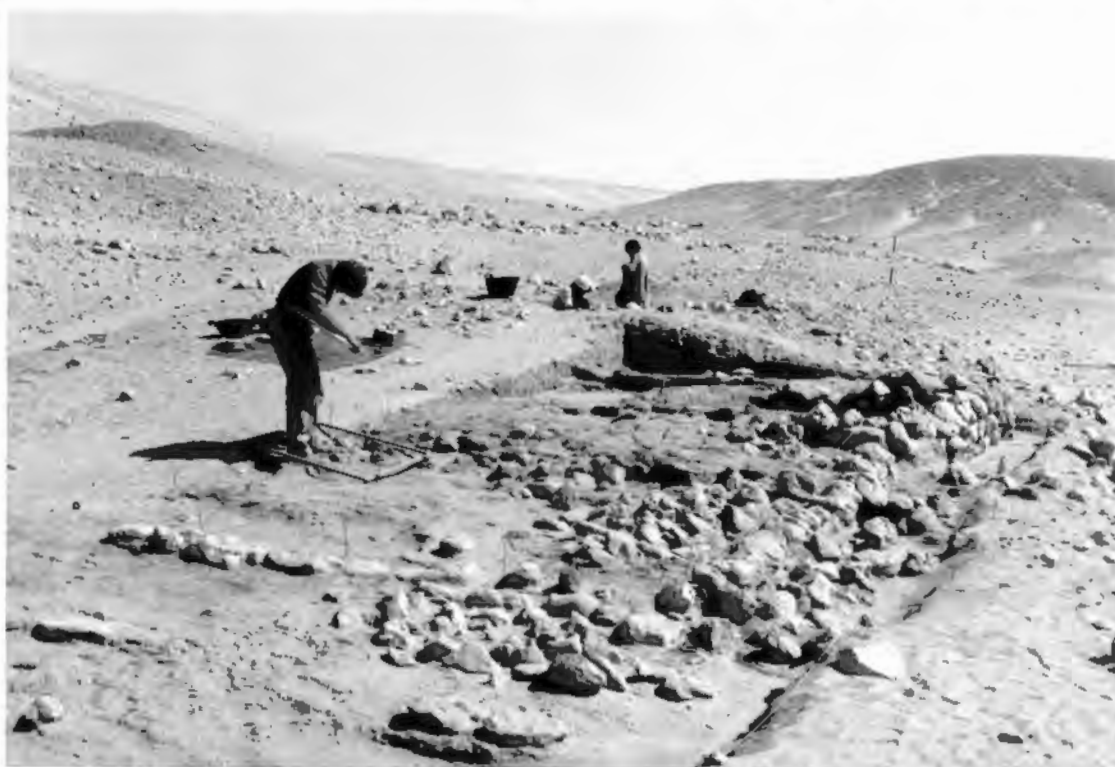
Figure 3.1. Chapel 571 at an early stage of excavation, with top of rubble exposed, looking north-east.
