# **Visitor route around the Central City at Amarna**

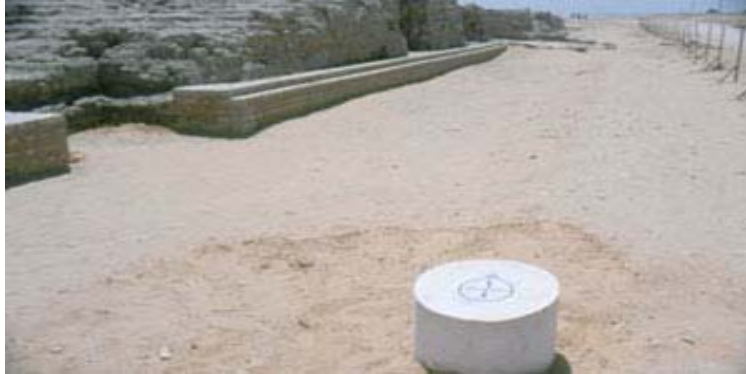
At marker 1

At the front of the Small Aten Temple, in front of the northern brick tower of the outer pylon and within the barbed-wire fence which protects the front of the temple from passing traffic. The modern road follows the line of Amarna's principal thoroughfare, Royal Road (so-called in modern times).

The enclosure around the Small Aten Temple was built from sun-dried mud bricks. The main entrance was in the centre of the west side, between two pylons, each measuring 14 x 8 metres. Akhenaten kept the tradition of erecting vertical wooden poles against the front faces of the pylons, each one set within a vertical slot in the brickwork. Pictures in the tombs show that cloth streamers were tied to the tops of the poles. Each pylon had two poles, represented by two deep vertical grooves in the brickwork, visible as you walk past the pylon on the left.

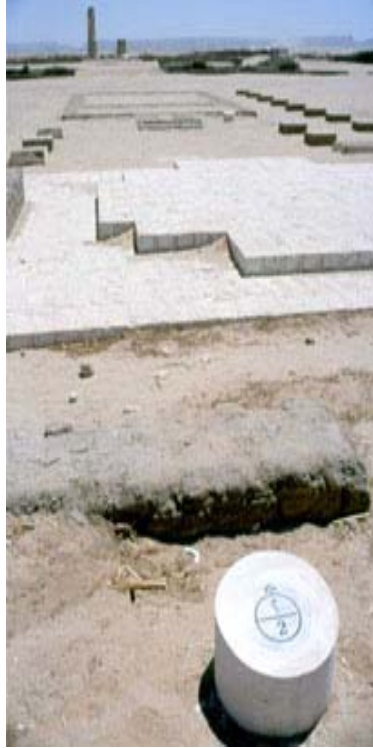
At marker 2

In front of the main entrance to the temple. The arrow points along the main axis of the temple.

The temple had three large courtyards arranged one behind the other. The gateways between the pylons were unusually wide, and had originally been floored with limestone blocks. These had been removed shortly after the end of the Amarna Period. We know this from the remains of gypsum foundation layers which have survived in these positions, and which still bear the imprints of the lowest layer of blocks. The gypsum layer in this outer gateway was particularly well preserved. A central raised portion showed that it had supported a central feature at a higher level, perhaps a pedestal for a pavilion reached by steps. The present limestone blocks are a modern restoration.

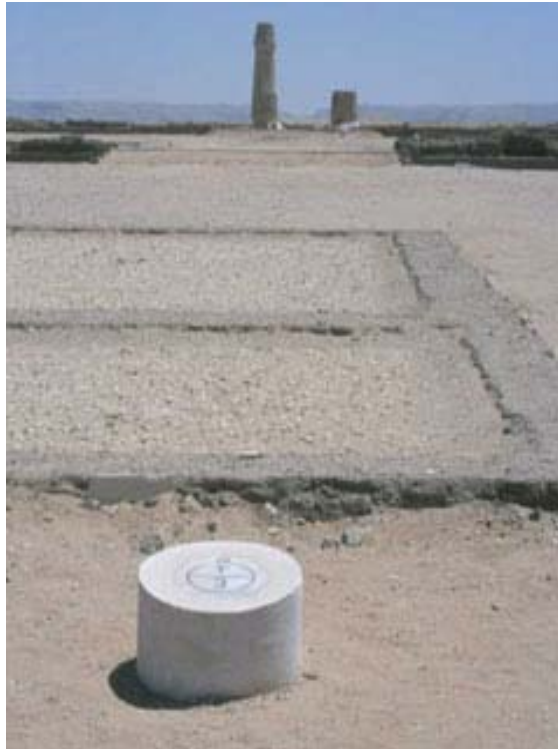
At marker 3

Beside the outline of a large platform or altar of mud bricks.

The brickwork, a layer of new mud bricks laid over an ancient foundation layer, marks the outline of a large altar belonging to the first phase of the temple, which had been built on a smaller scale than the temple enclosure which you now see standing. Both the earlier temple and the altar were subsequently demolished, leaving only the bottom of foundations. The altar seems to have had a set of steps or a ramp leading up to it on the west side. Pictures in the tombs show altars of this kind heaped with offerings, with figures of Akhenaten and his family praying to the Aten.

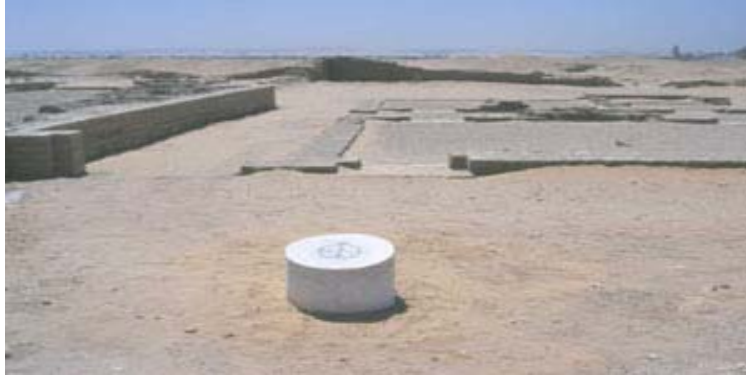
At marker 4

In front of the third pair of pylons lies a small brick building, called in modern times the 'Priest's House'. The arrow points towards it.

When first excavated the building was already very ruined although the plan was almost complete. Much of the visible brickwork, including the brick floors, are modern. The purpose of the building is not properly understood. The main room contained a small brick dais on its north side, with a central projection for a narrow staircase.

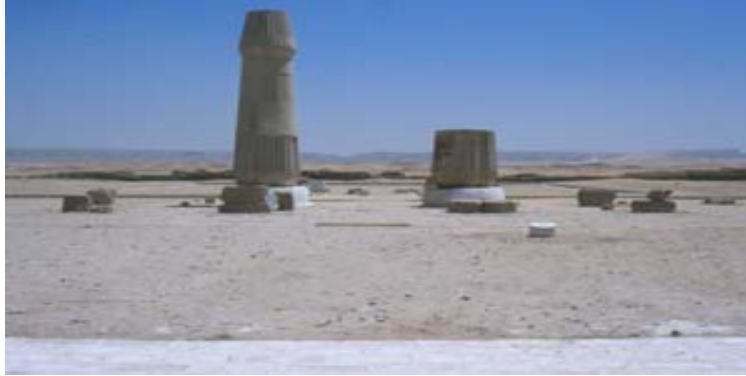
Between markers 4 & 5

In front of the Sanctuary of the Small Aten Temple.

In the centre of the third court there originally stood a monumental stone building, the Sanctuary. This would have been decorated with scenes in the Amarna style, carved and brightly painted. After the end of the Amarna Period most of the stonework was removed. What remained behind was a large spread of gypsum foundation mortar bearing the impressions of the lowest course of stone blocks. From this it is possible to reconstruct the outline of the Sanctuary, and this has been done using new limestone blocks. Some large pieces of the original sandstone columns and other architectural elements were left behind and these are displayed. On the basis of the pieces of column a complete example has been erected using modern materials, to give an idea of the original height of the building.

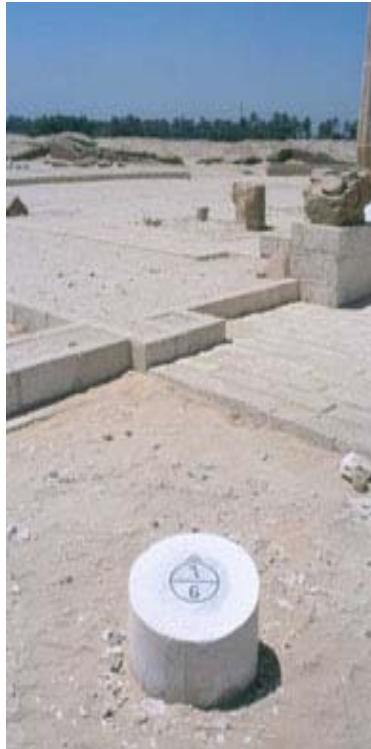
At marker 6

On the axis of the temple, slightly beyond the foundations of the fourth pylon which, unlike the others, had been built of limestone blocks. The doorway between the pylons had probably contained a doorframe made of large sandstone blocks. Part of one of these has been set on top of modern limestone blocks on the south side of the doorway. It bears the top of a cartouche of the Aten carved on a gigantic scale. On the opposite (northern) side of the doorway is a sandstone block from the lintel or from a cornice connected with the columns. It originally bore the cartouche of Nefertiti but this has been chiseled out in readiness for the carving of a replacement name. The recarving was never done.

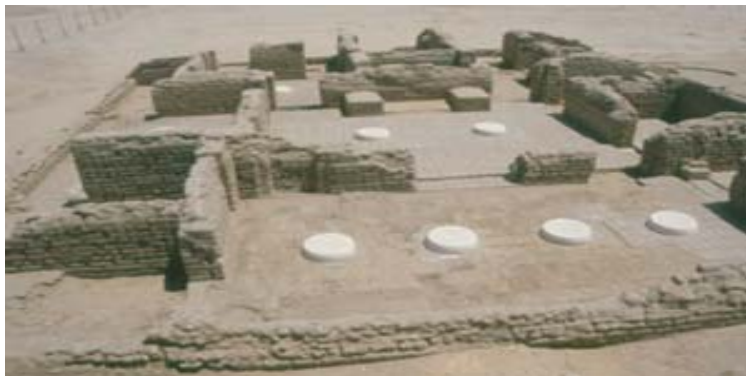
House Q44.1 after clearance with the long antechamber with reconstructed column bases in the foreground

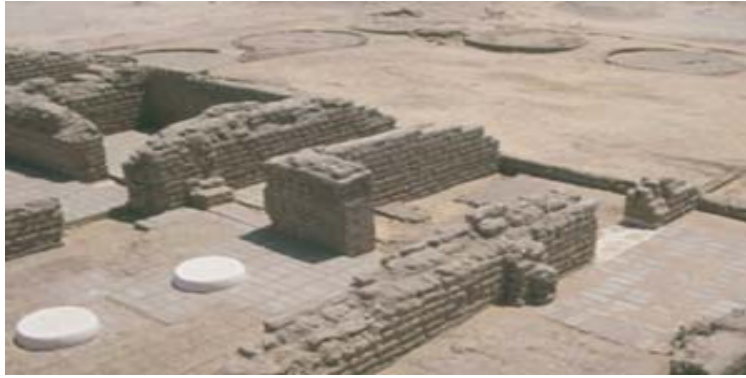
View through house Q44.1 with the granary court in the background

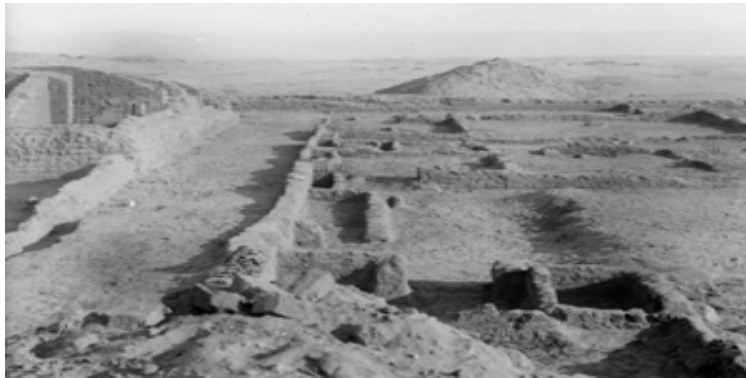
House Q44.1 at the end of the 1923 excavation, viewed to the north. The east wall of the house is on the left. In front are the walls of kitchens and perhaps servants' houses. EES neg. 23/20.

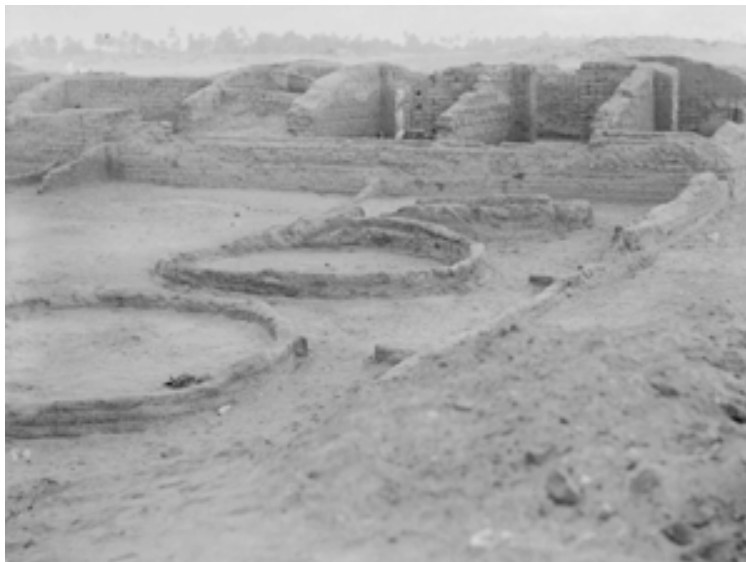
House Q44.1 at the end of the 1923 excavation, viewed towards the north-west. The south wall of the house is in the background. In front are the lowest courses of brickwork belonging to the circular grain silos. EES neg. 23/21.

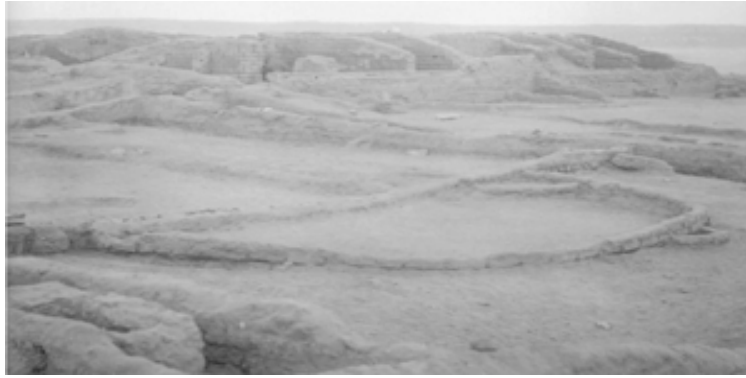
House Q44.1 at the end of the 1923 excavation, viewed towards the north-east. The south-west corner of the house, with the entrance lobby, is in the background. In front are low walls belonging to courts adjacent to the cattle shed and which might also have served for the keeping of animals. EES neg. 23/23.

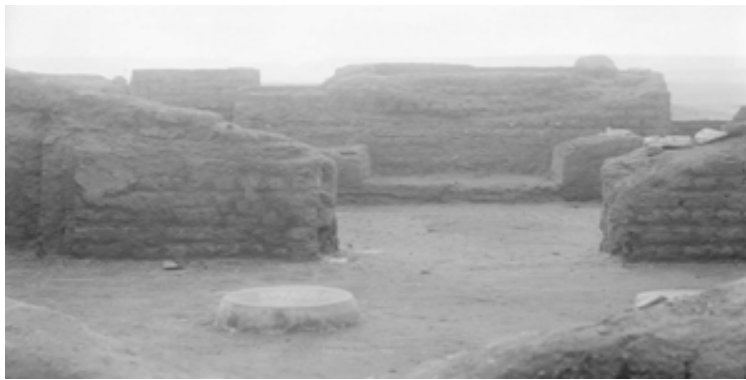
House Q44.1, a closer view to the east into the interior of the house. Against the rear wall of the central room is a well preserved low brick bench provided (unusually) with thick end walls. EES neg. 23/25.

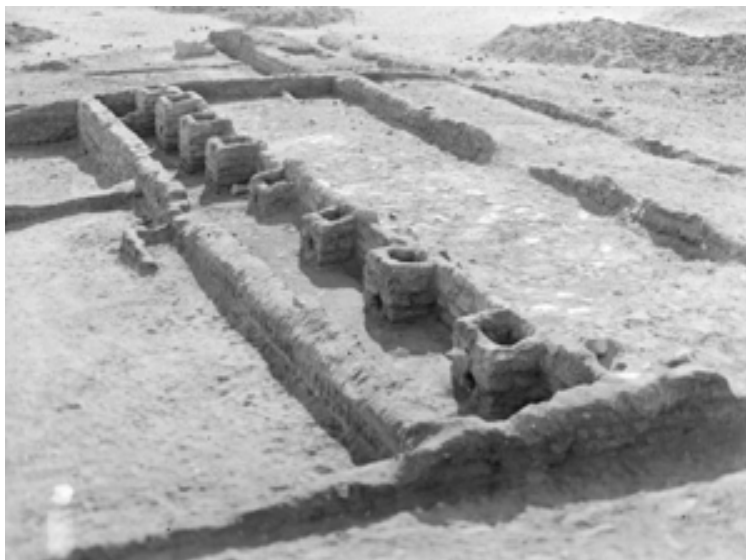
House Q44.1 at the end of the 1923 excavation. The view, towards the south-west, is of the cattle shed. The rough stone floor and brick mangers were well preserved. EES neg. 23/31.

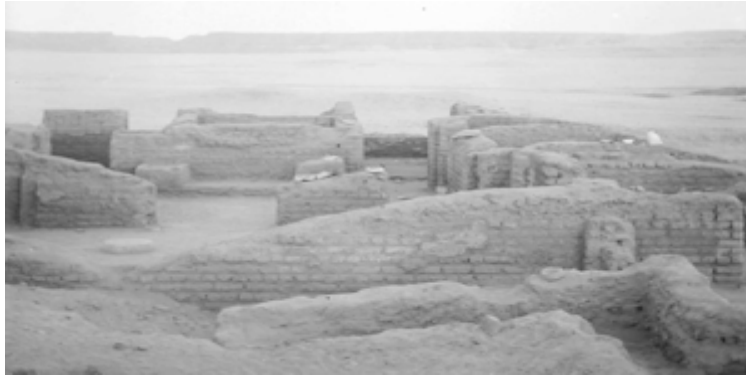
House Q44.1, a view to the east into the interior of the house. Against the rear wall of the central room is a well preserved low brick bench provided (unusually) with thick end walls. EES neg. 23/24.

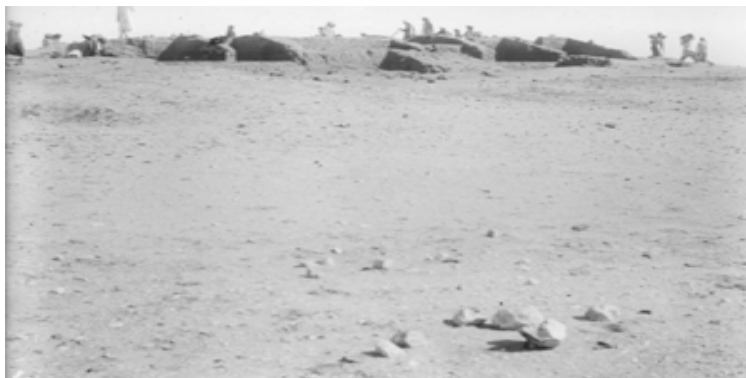
General view towards the north-east of the excavation of Q44.1 in progress. Only the walls of the house have been exposed. The courtyard containing the granaries lies in front, not yet excavated. The walls of the house were thicker and had therefore been preserved to a greater height. EES neg. 23/17.

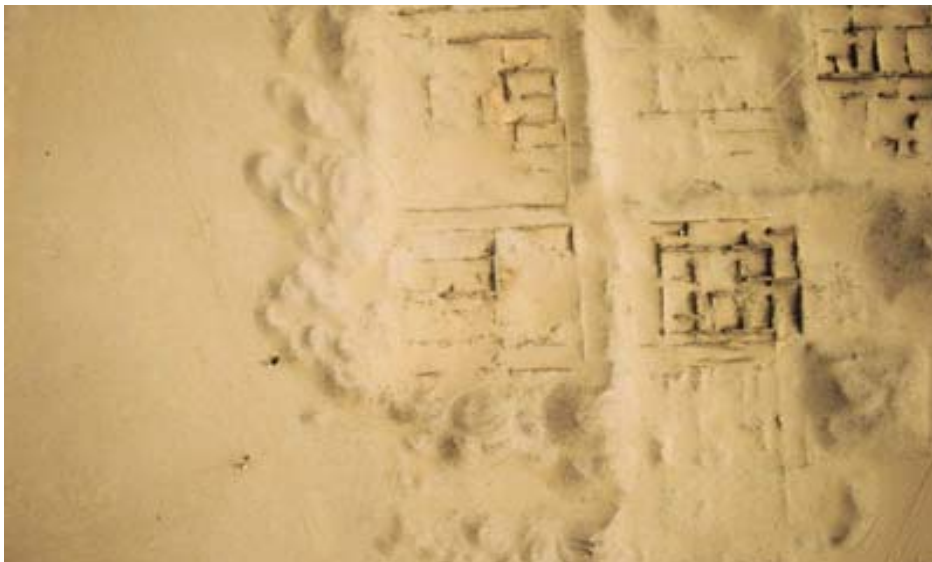
Aerial photograph of the 'Bureau of Correspondence of Pharaoh', the poorly preserved building in the very centre of the image surrounded by undulating spoil heaps along its western, southern and eastern faces (north corresponds, approximately, to the top of the image)

The walls of this modest and now very ruined building included bricks stamped with the words 'Bureau of Correspondence of Pharaoh'. It was here, in a pit in the floor, that local villagers discovered a deposit of clay tablets around the year 1888.

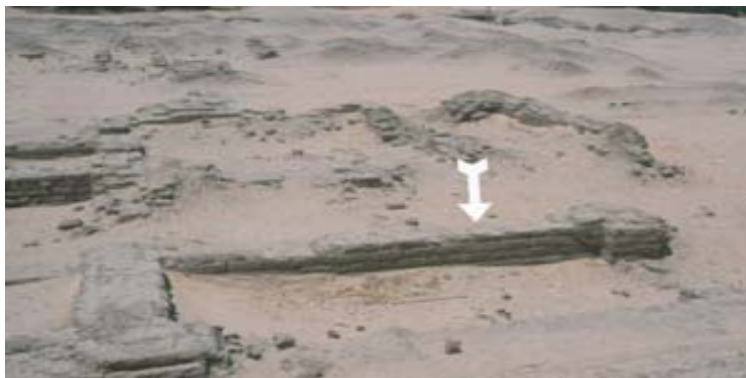
The remains of the King's House showing the location of the wall painting of the royal family discovered by Flinders Petrie

Turn and look to the left (west). Below lie the walls of the King's House which seems to be a small and private palace for Akhenaten. The rooms immediately across from the marker seem to be personal rooms for members of the royal family. In 1892, on the wall of one of them, the archaeologist W. Flinders Petrie found part of a wall painting which showed Akhenaten and Nefertiti relaxing, with their daughters seated at their feet. Petrie removed a part which showed two of the daughters. This is now in the Ashmolean Museum, Oxford. The arrow marks the original place of the painting, which was on the far side of the wall.

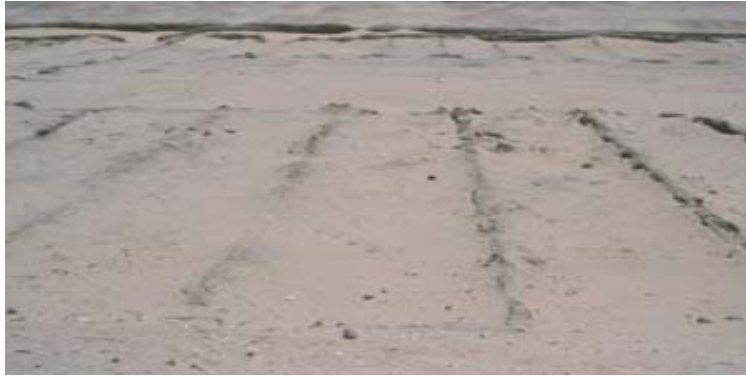
Turn and look to the east. The ground is subdivided by two sets of parallel brick walls on either side of a courtyard. These belong to storerooms which were probably used mainly for grain (wheat and barley). This was a large private store of agricultural wealth at the disposal of the king.

Parallel lines of mud-brick walls: the royal storerooms

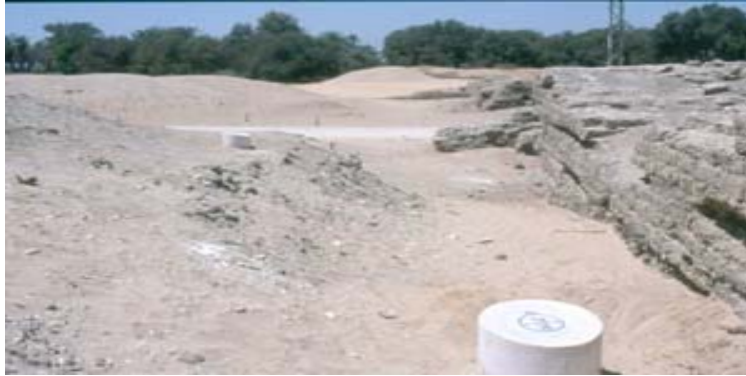
At marker 15

Beside the thick side wall of a ramp which led up to a massive bridge which crossed the line of Royal Road and so joined the King's House to the Great Palace on the far side. The ramp consists of two parallel walls which retained a fill of sand and gravel. This was removed during the 1931 excavation. The ramp is 9 metres wide. As you walk beside the wall notice the deep horizontal grooves in the face of the brickwork. These mark the places where beams of wood were laid in the brickwork in order to bind it together and reduce the likelihood of cracking.

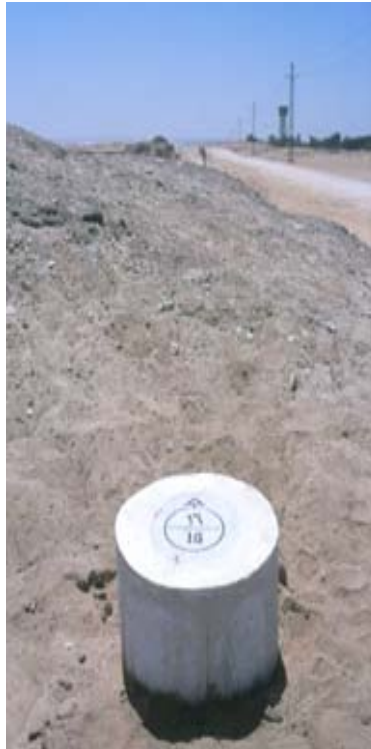
At marker 16

Marker no. 16 is the last of the series and points back towards start of the route. Before leaving turn and examine the end face of the ramp and the brick pier beside the road which supported the bridge. Notice how the wooden beams have become even more closely set, appearing in every alternate course of bricks. They had to help the brickwork bear the weight of the bridge, which must have been supported on heavy massive timbers.
