British Mission to Tell el-Amarna

**Great Aten Temple  
Report on Recent Work  
(September 16th–November 4th, 2021)**

## Preliminary report on work done by the British Mission to Tell el-Amarna, September 16th–November 4th, 2021

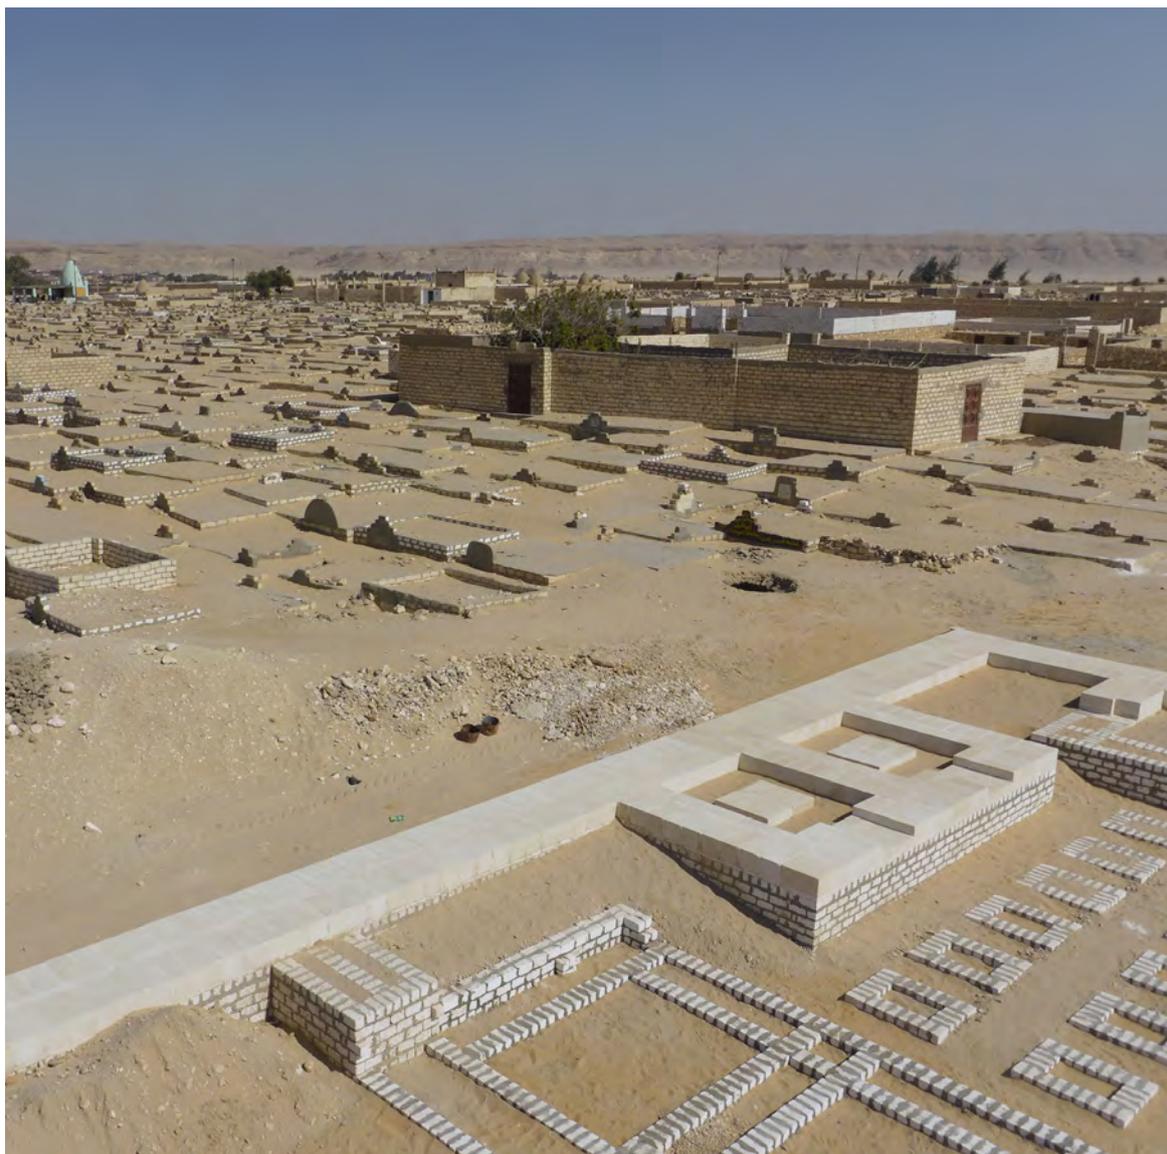
*View of the north-east corner of the Long Temple at the end of the autumn season, 2021. The modern cemetery of El-Tell stands beside it. View to the north-east.*

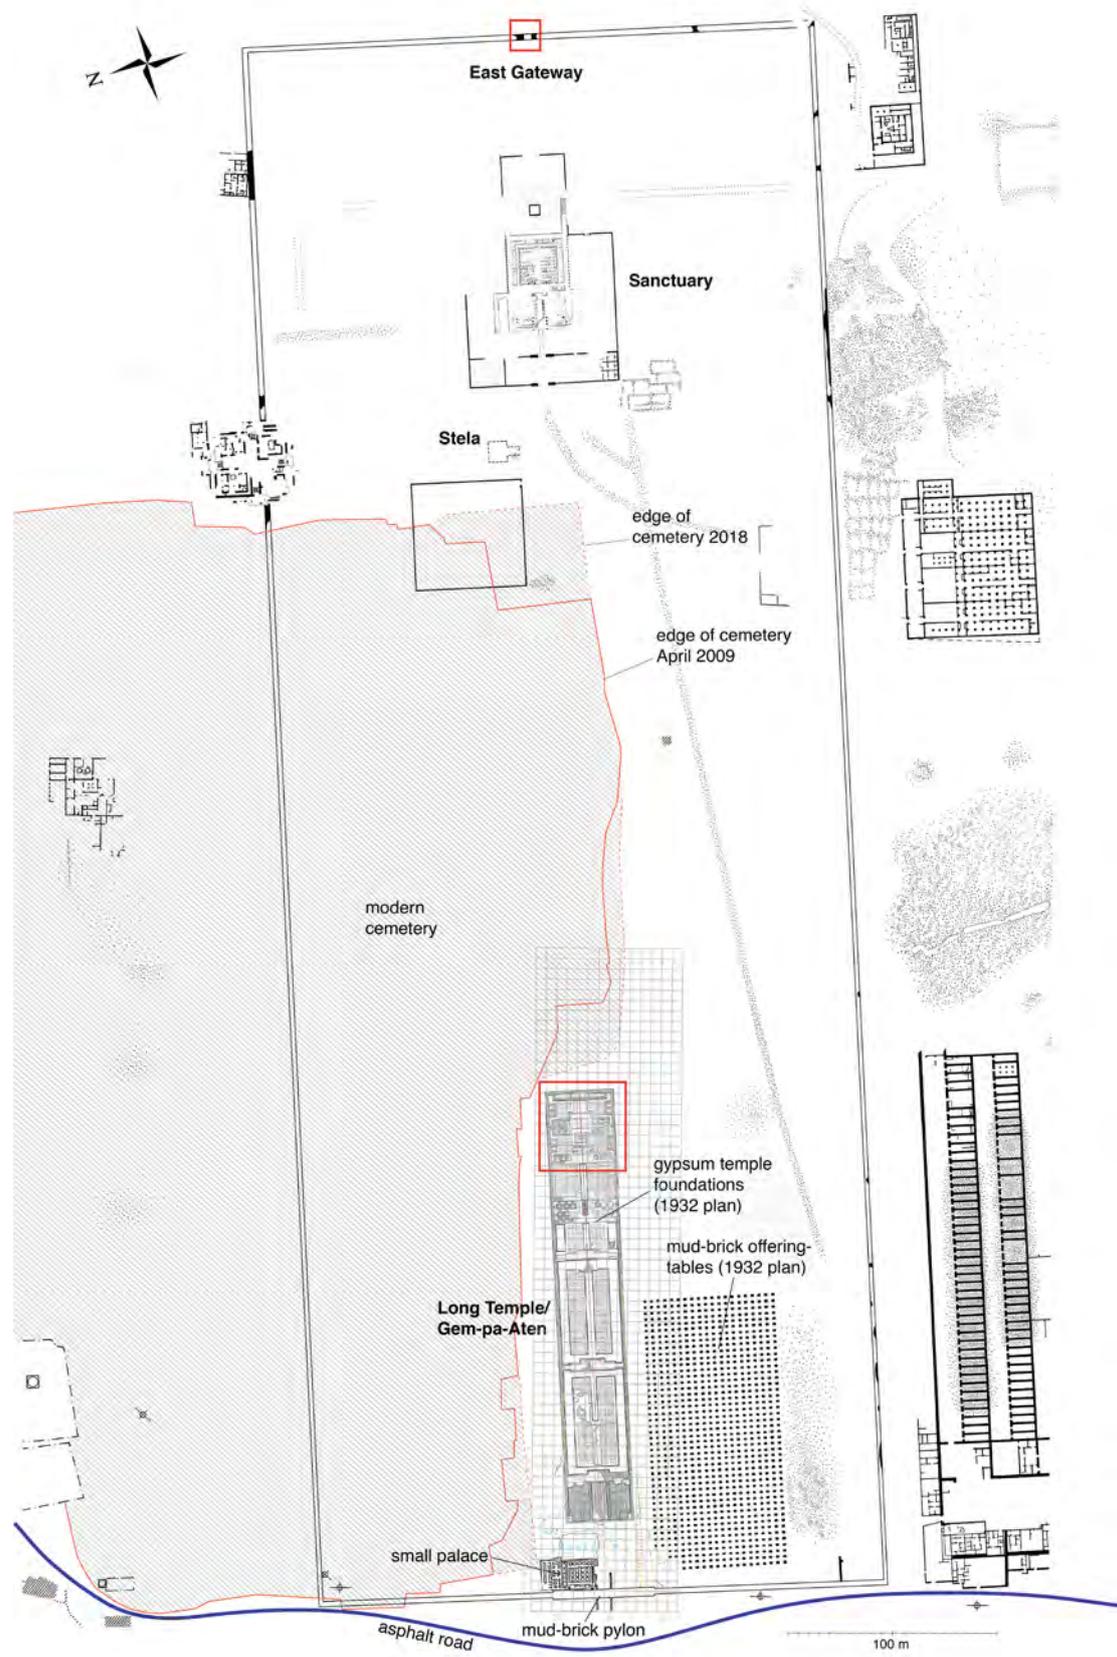
Figure 1. Plan of the enclosure of the Great Aten Temple. It shows the main features within the enclosure and the main areas of the 2021 season which are outlined in red (see Figure 2).

The excavation and rebuilding work were located within the large enclosure of the Great Aten Temple (Figure 1). The main building within the enclosure is the Long Temple. It was originally built from blocks of limestone of the standard size of 1 cubit long (52 cm) by half a cubit wide and tall (*talatat*-blocks). Akhenaten's builders had developed the technique of erecting stone buildings on a foundation layer of concrete, in which gypsum was used instead of lime cement. Some years after Akhenaten's death, all stone buildings (including the Long Temple) were demolished and the stones taken away to be re-used for other projects (most importantly at El-Ashmunain). Fortunately for modern understanding, the removal of the stones commonly left behind large areas of the gypsum-concrete foundation layer. This layer preserves traces of where walls and other features had been. When these traces are recorded and studied it is possible to reconstruct the plan of the building.

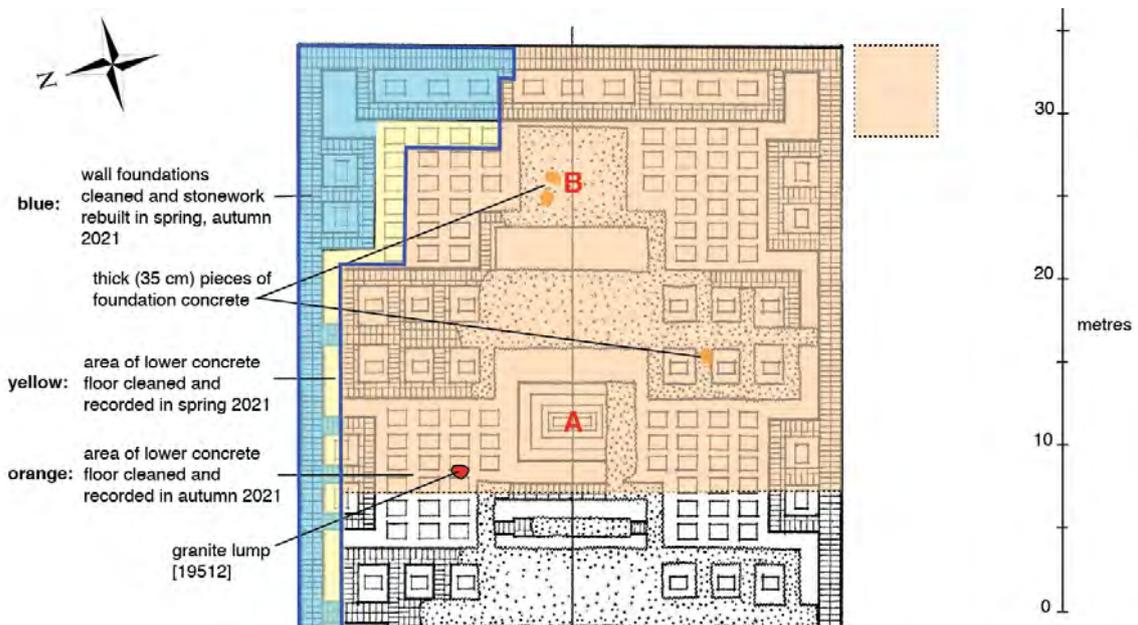
Figure 2. Plan of the rear part of the Long Temple showing the progress of the work of study and reconstruction achieved in 2021. The red letters A and B refer to the positions of the large offering-tables shown in the tombs of Meryra and Panehsy (Figures 6–8). The underlying plan is that of Ralph Lavers, made for the Egypt Exploration Society expedition of 1932 (City Of Akhenaten III, Pl. III).

In the spring of 2021 the cleaning of the gypsum concrete foundations reached the back of the temple (which has a width of 32 m) along the line of the north outer wall. The work of this autumn season was to continue to clean and to record more of this area across to the south outer wall (Figures 2 and 3). The foundation layer is covered with about 10 cm of wind-blown sand which becomes thicker at the edges. As we proceeded we used, for reference purposes, the small-scale plan made by Lavers in 1932. A fresh plan, at the scale of 1:25, was then made by Juan Friedrichs (Figures 4 and 9). It records traces of the builders' original lines (marked in black ink or by lines cut with a chisel) and marks of damage made when the original limestone blocks were removed. From a study of all of the evidence it is possible to restore the original plan. The surface is also photographed, in part by a tiny remote-controlled camera on top of a long pole. Computer software can then create a mosaic aerial photograph covering large areas.

On the 1932 plan, in the easternmost of the positions where we expect to find the two large offering-tables (B in Figure 2), the area of the gypsum-concrete layer has been entirely destroyed. In the westernmost, by contrast, most of the area is preserved and is filled with a series of five concentric rectangles (A in Figure 2). This season's cleaning of the foundation layer has included both areas. The first, on the east, confirmed the outlines of the 1932 plan: the entire surface of the rectangular area has been destroyed so that only an empty space which exposes the underlying sand survives. The second, on the west, had survived fairly well. A plan is given here accompanied by the Lavers' version (Figure 9). The traces that remain of the structure that stood here are difficult to interpret. Lavers saw some of them and resolved them into a set of five rectangles nested inside one another. One can understand why he did this, but the result is, nevertheless, not entirely faithful to what is there.

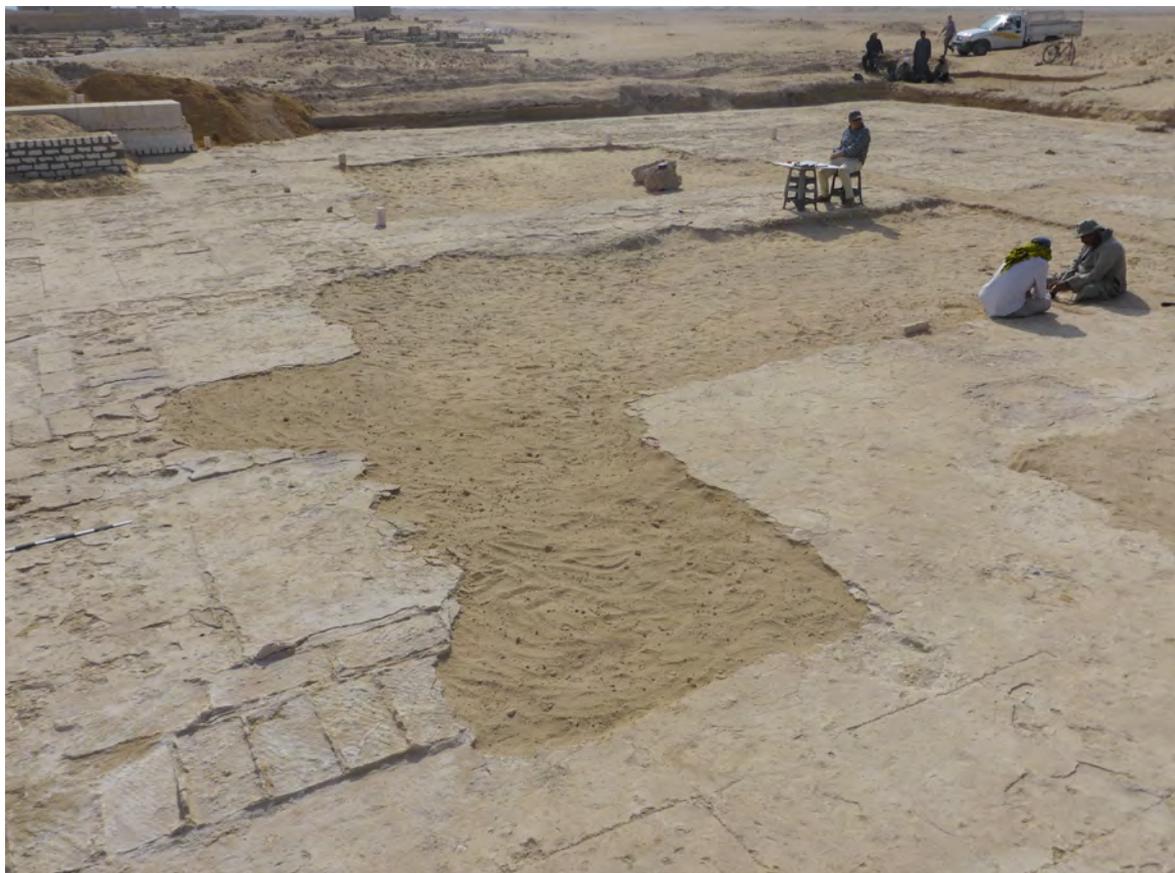
Figure 3. Part of the gypsum-concrete foundation layer at the rear of the temple. Some areas were destroyed when the temple was demolished. Other areas preserve the marks of walls and offering-tables. View to the south-east.

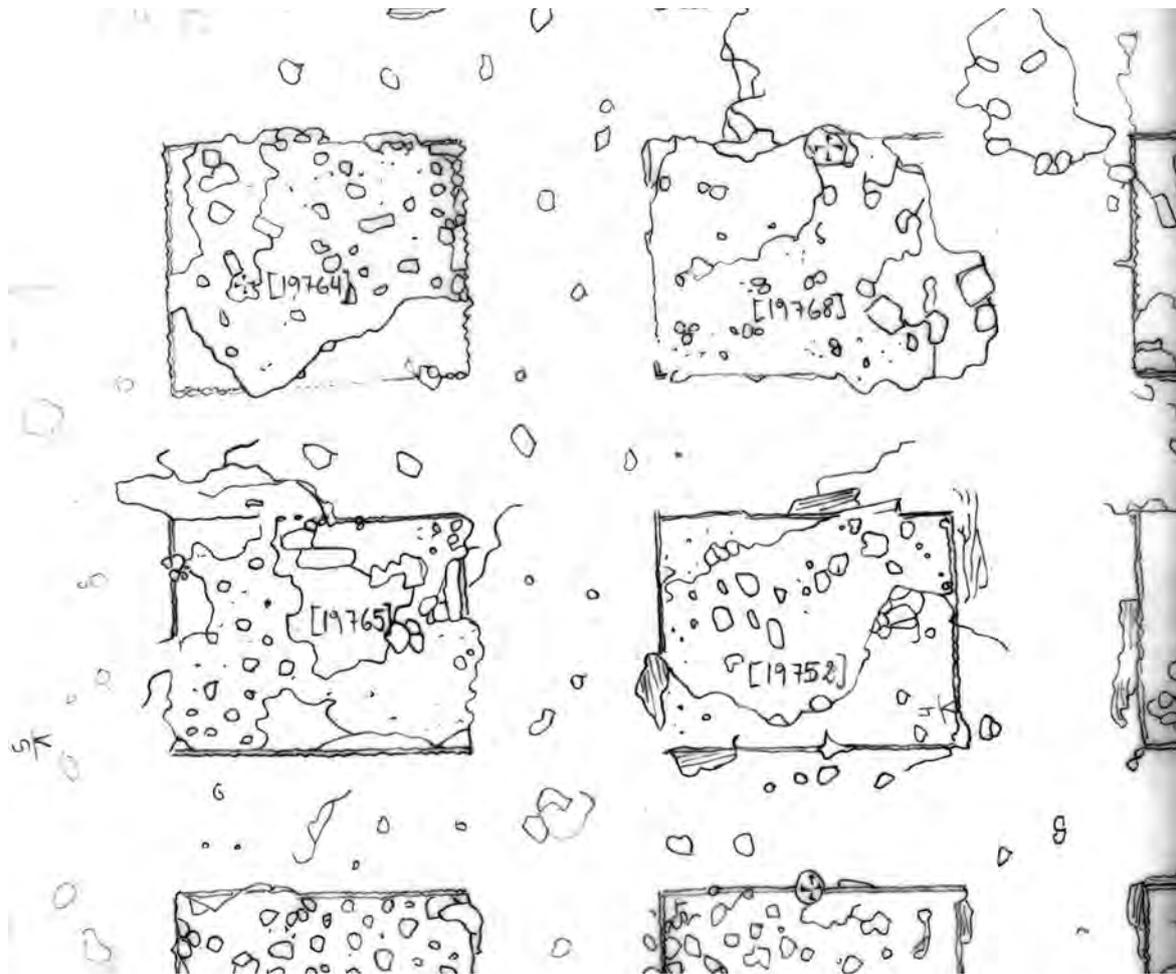
Figure 4. Part of the new plan of the area of the temple foundations uncovered in the autumn of 2021, drawn by Juan Friedrichs. It covers a group of offering-tables. East is towards the top.

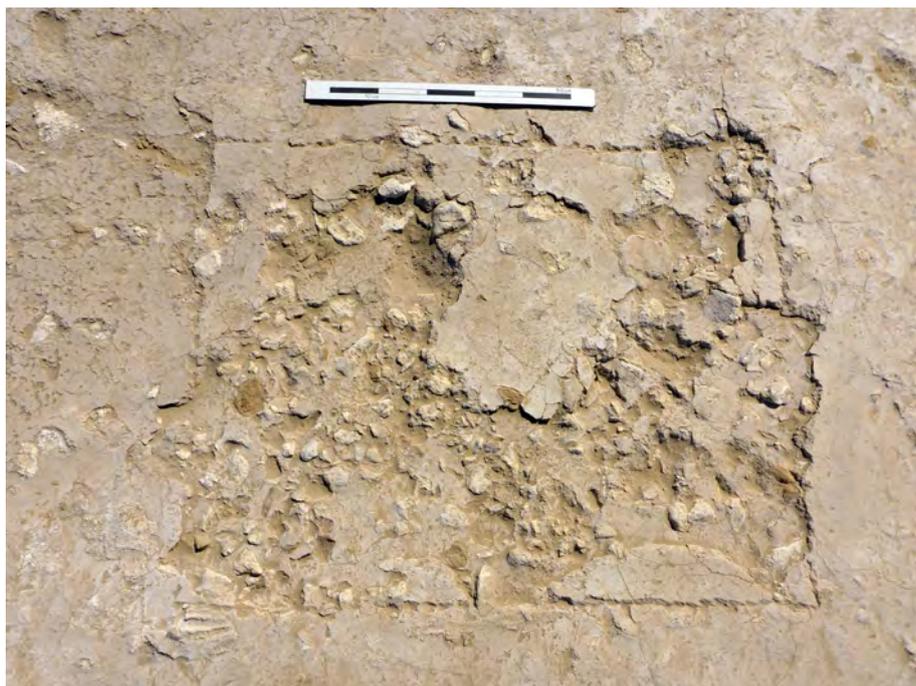
Figure 5. Traces of offering-table [19765], see Figure 4. East is towards the top.

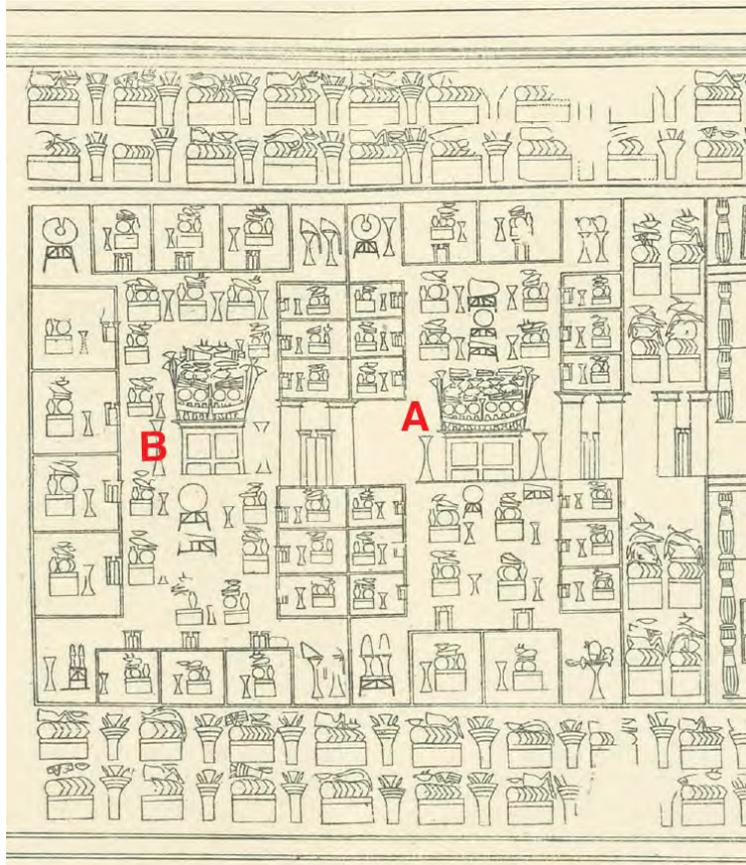
Figure 6. The rear part of the temple as shown in the tomb of Meryra (Davies, Rock Tombs I, Pl. XXVIII). The red letters A and B identify the two main offering-tables (see Figure 2).

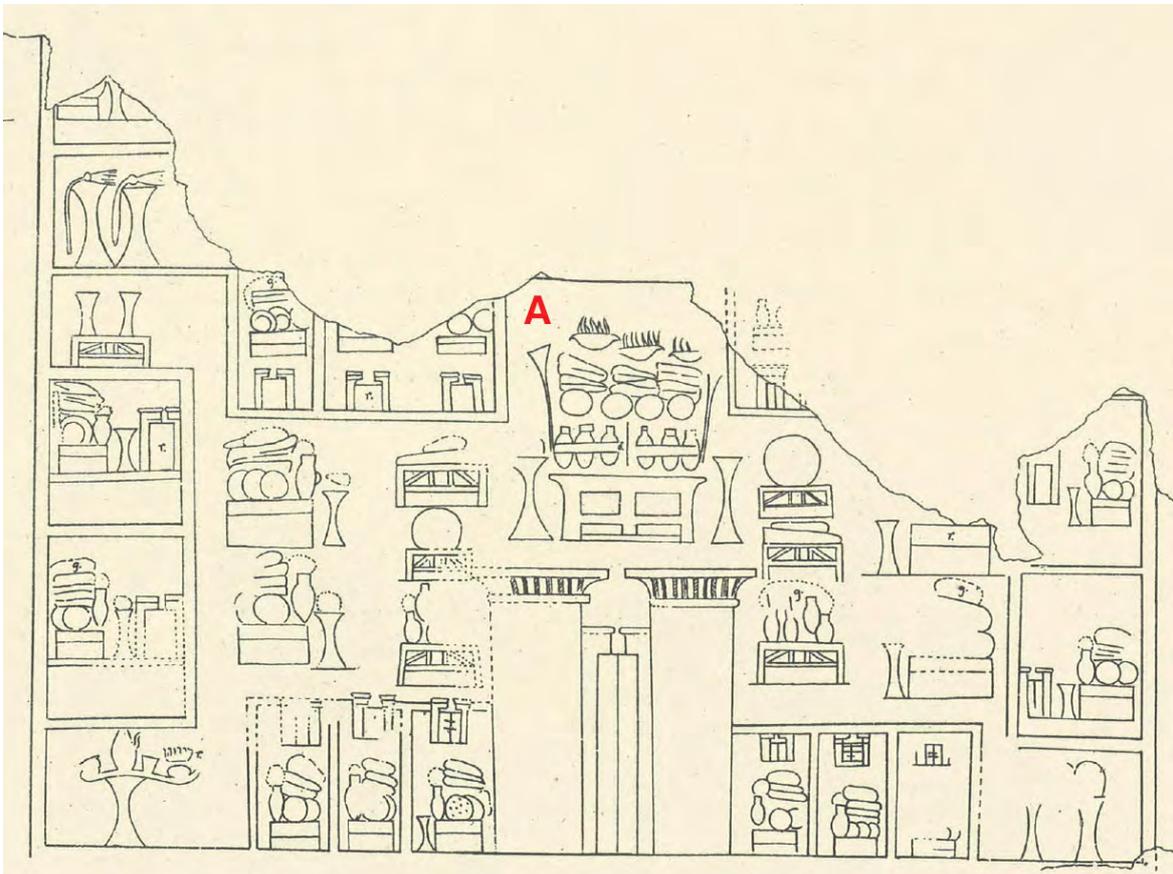
Figure 7. The rear part of the temple as shown in a second scene in the tomb of Meryra (Davies, Rock Tombs I, Pl. XI). The red letter A identifies one of the two main offering-tables (see Figure 2).

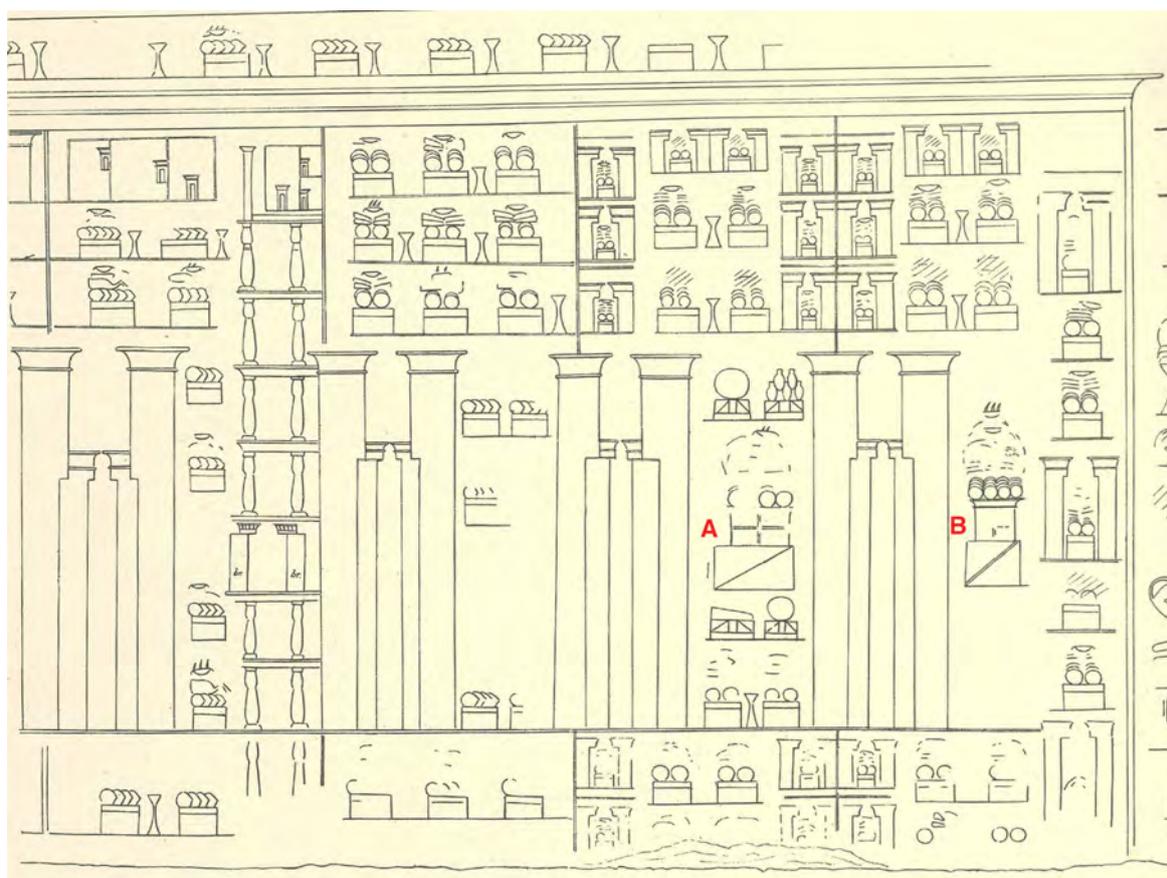
**Figure 8.** The rear part of the temple as shown in the tomb of Panehsy (Davies, *Rock Tombs II*, Pl. XIX). The red letters A and B identify the two main offering-tables which here appear to stand on solid bases (see Figures 2 and 9).

The entire temple was open to the sky. The rear part was, however, filled with walls which created many small rooms which contained offering-tables the foundations of which were built from limestone blocks. More offering-tables of the same kind filled the remaining spaces except for two rectangular areas on the temple axis which were occupied by larger offering-tables of more elaborate design. Pictures in the rock tombs of Meryra and Panehsy at Amarna show details of these two larger offering-tables (twice in the case of Meryra, Figures 6 and 7). With Meryra they appear to be not solid but of openwork construction, thus either of wood perhaps overlaid with gold leaf, or of metal (perhaps an alloy of gold with copper). In the tomb of Panehsy the two larger offering-tables (perhaps of openwork construction though stylised) appear to stand on solid bases crossed by a diagonal line (Figure 8). Is this detail trying to convey the sides of staircases?

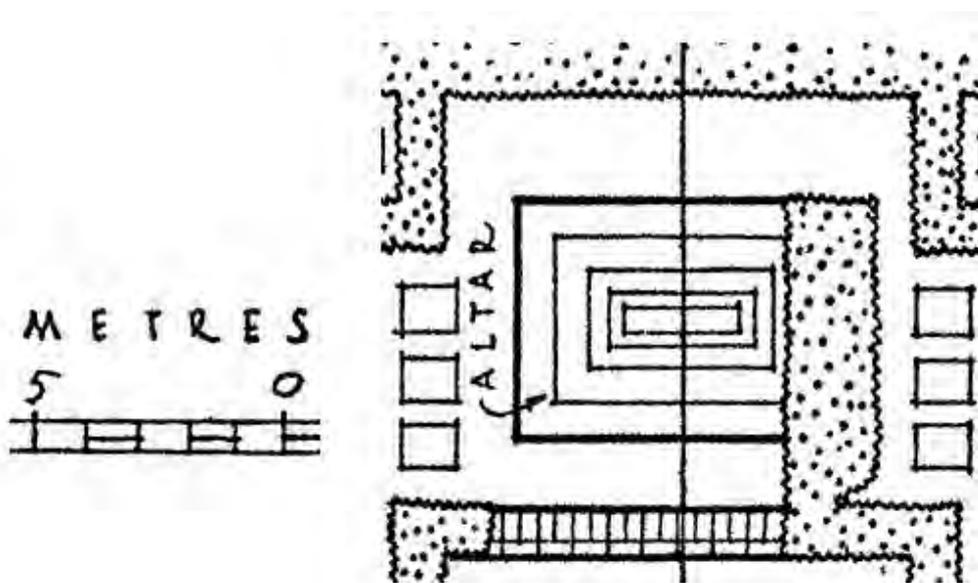
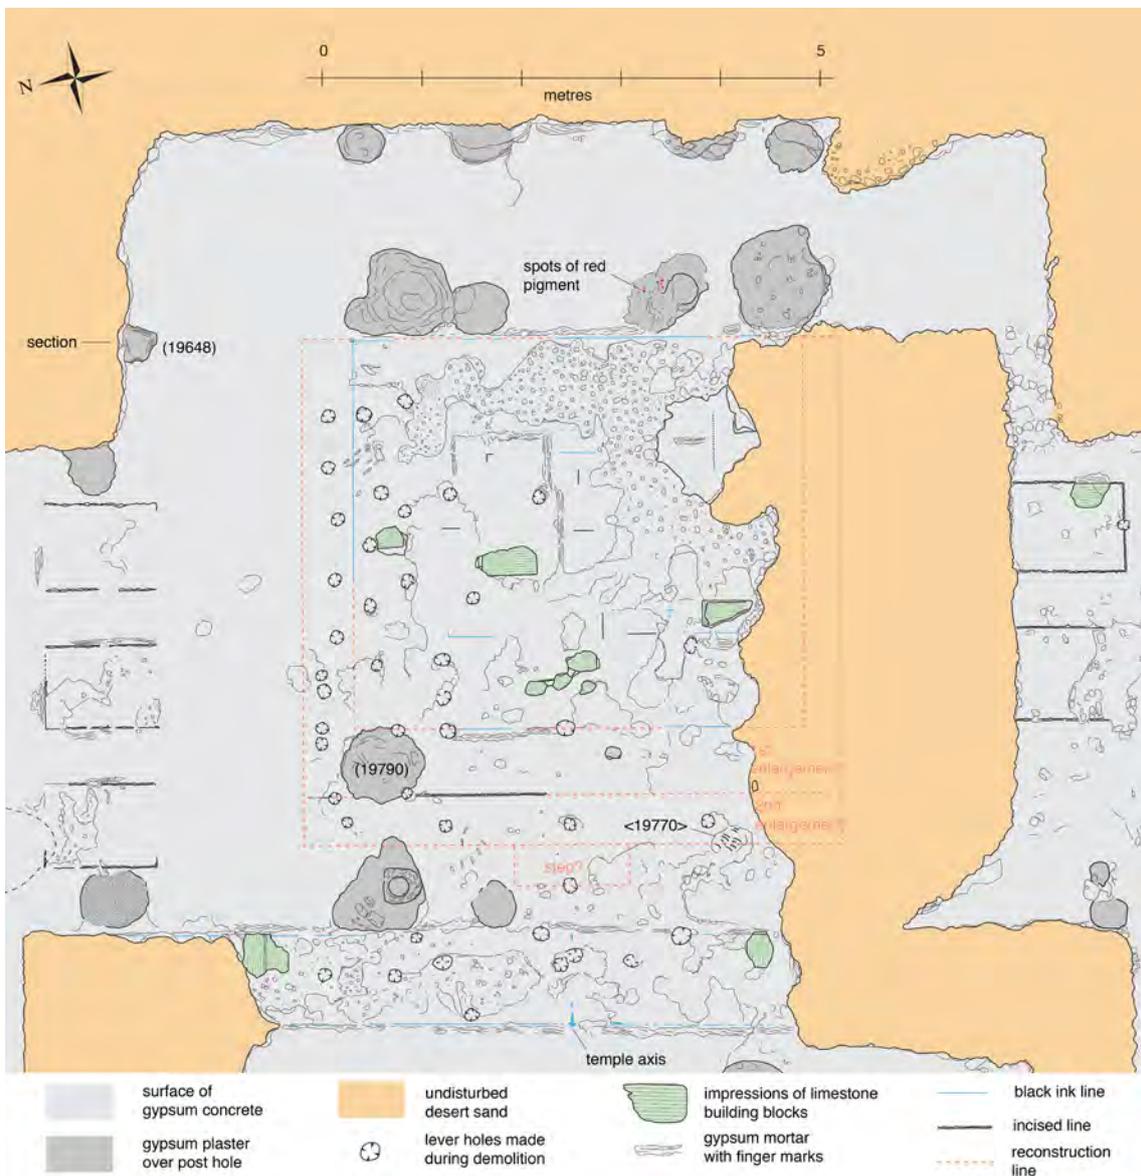
Figure 9. Detail plan of the location of the western main offering-table ('A' on Figure 2). Original by Juan Friedrichs. At the top is the corresponding area in the 1932 plan of Ralph Lavers.

Similar, roughly circular fills of gypsum concrete, covered with a smooth capping of gypsum plaster, also occur in the centre of the foundation layer (Figures 9, 10). The greater number cluster around the space which, according to the tomb pictures, was occupied by the western large offering-table. Some of them are in pairs, and often the pairs give the impression that each of the pairs was made on a separate occasion. In two places where the holes are on a broken edge to the foundation layer it is possible to examine them in section. For one of them the underlying sand was so loose as to prevent the examination from proceeding far. For the other ((19648), Figure 11) it was possible to probe to the bottom of the original hole, which was 50 cm deep (measured from the surface of the foundation platform). The hole had been filled with sand and stones when the pole had been removed, above which came gypsum concrete and a final layer of gypsum plaster. This confirmed that the circular patches on the surface do, indeed, mark the positions of post-holes, cut and then filled again before the laying of stone blocks took place.

The cleaning of the gypsum-concrete foundation layer also revealed patches of pigment (red, orange, blue, black and occasionally green) on the floor and sometimes covered with a thin layer of cemented gypsum, probably accidentally present. A particular concentration lay in a space in the south-east corner of the temple. We cannot say whether any tools or equipment (e.g. pottery pigment containers) had also been present since the 1932 excavations had carried out a thorough sweeping of the surface before photography. We must remember that the surface served as a floor only for the time before the ground level was raised with sand, and a second layer of gypsum concrete and the real floor of limestone slabs was laid over the top. The mixing of pigments must have occurred because the carving and painting of the wall decoration began at the earliest possible moment, perhaps when only a few courses of stone blocks had been laid and well before a wall had been fully built. One patch lay beside the western main offering-table (Figure 9).

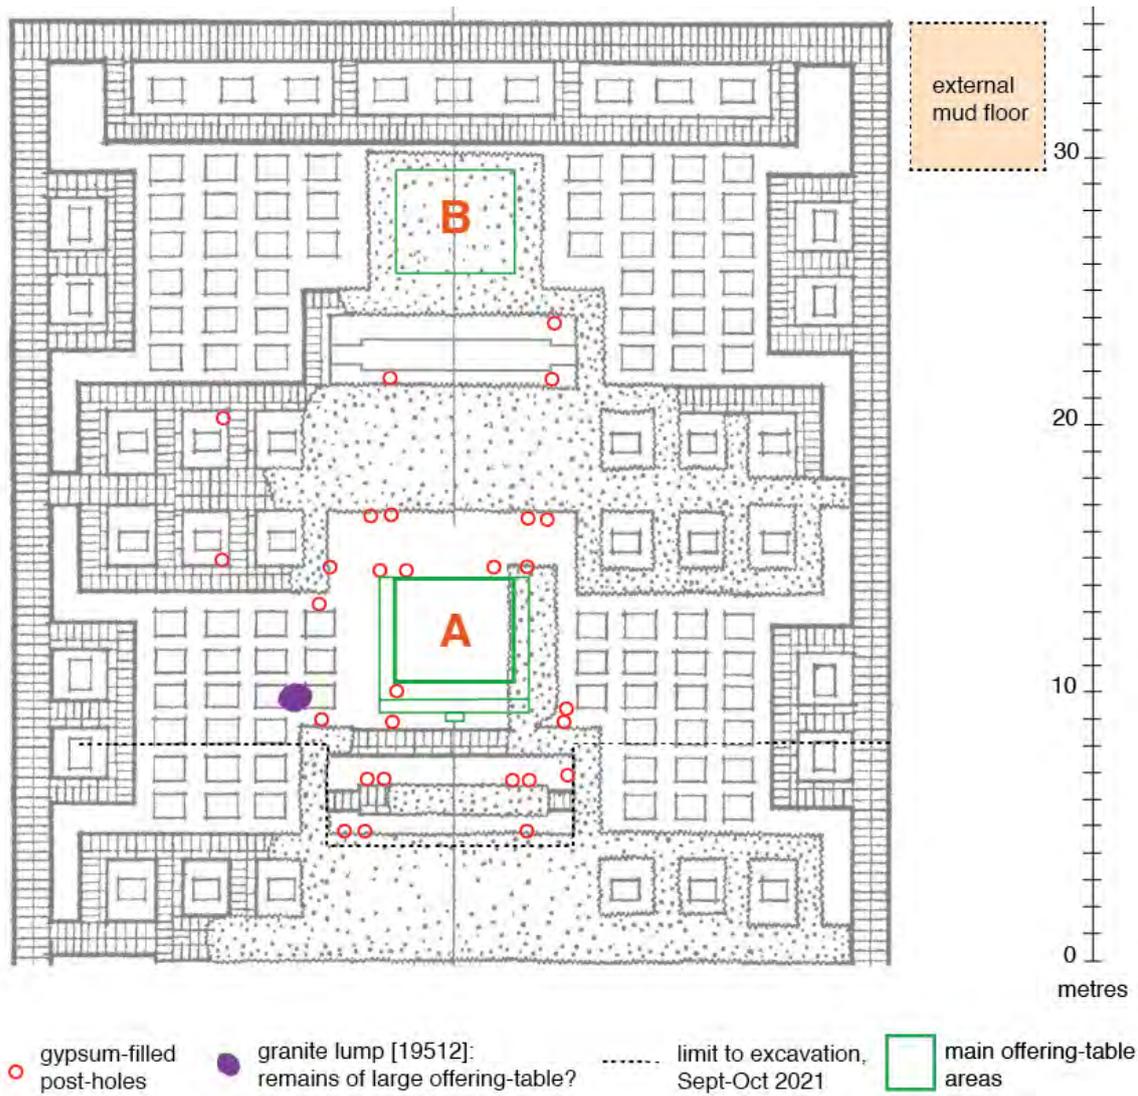
Figure 10. The rear part of the temple (using the Lavers plan of 1932). The reconstructed shapes of the main offering-tables are added in green; the locations of post-holes cut into the gypsum-concrete foundation layer within the interior of the temple are outlined in red.

The work of the spring season had drawn attention to a large rounded lump of granite which has stood close to area A since the time of Pendlebury (Figures 2 and 10). Several carved fragments of granite from the same general area might have come from it. It was suggested that the large offering-table which had stood in area A was actually made from granite of which the rounded lump is a remnant. This would imply that the tomb pictures are showing a stylised, hieroglyph-like representation rather than a picture of what actually stood in this place.

The plan of Ralph Lavers captures the essence of the process of destruction. It was evidently carried out by many groups of workers who, in the central parts of the foundations, had a tendency to start from the south and to work northwards (visible in Figure 10). Fortunately for us, they frequently abandoned the task before finishing,

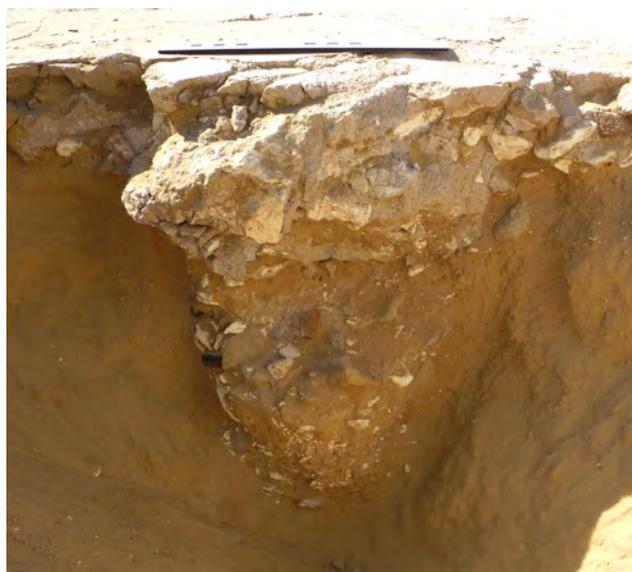
Figure 11. Section through the fill (19648) of a post-hole in the gypsum-concrete foundation layer.

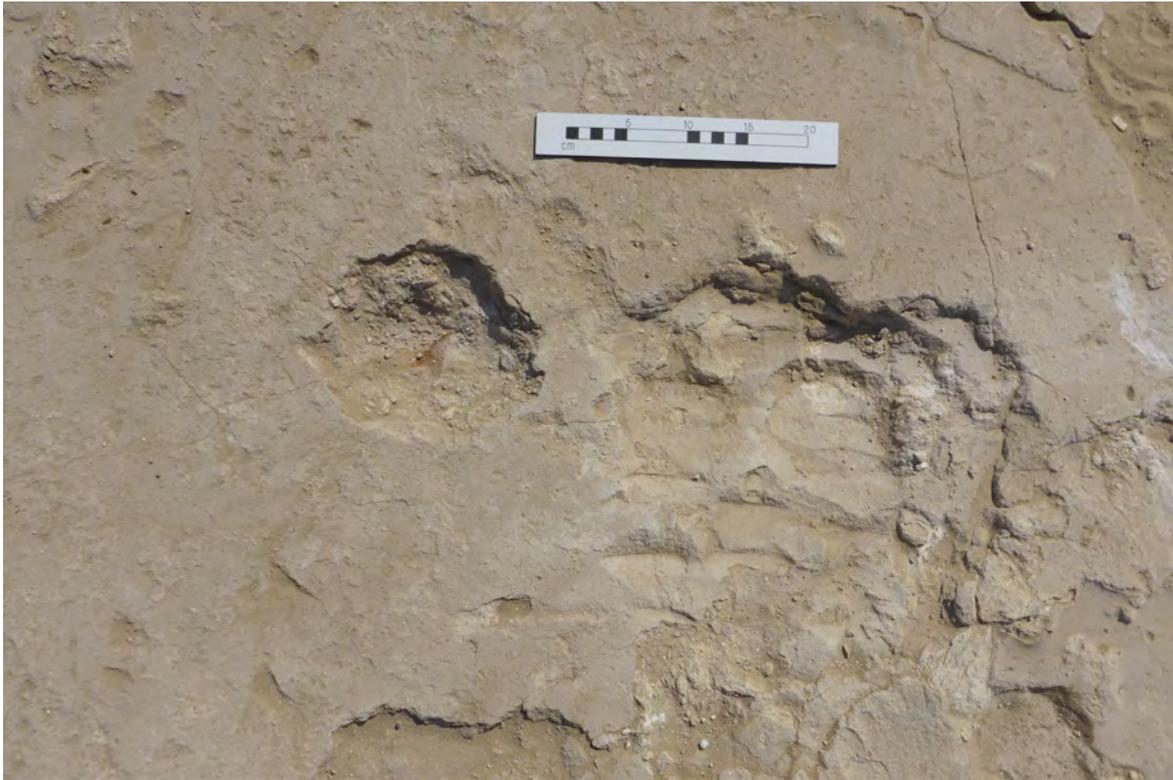
**Figure 12.** Surface of the gypsum-concrete foundation bed at the southern edge of the area of the western main offering-table. The circular hole is one of the cup-shaped lever holes used in the removal of talatat-blocks. The area of damage to the right has been caused by repeated blows with a bladed tool. East is towards the top.

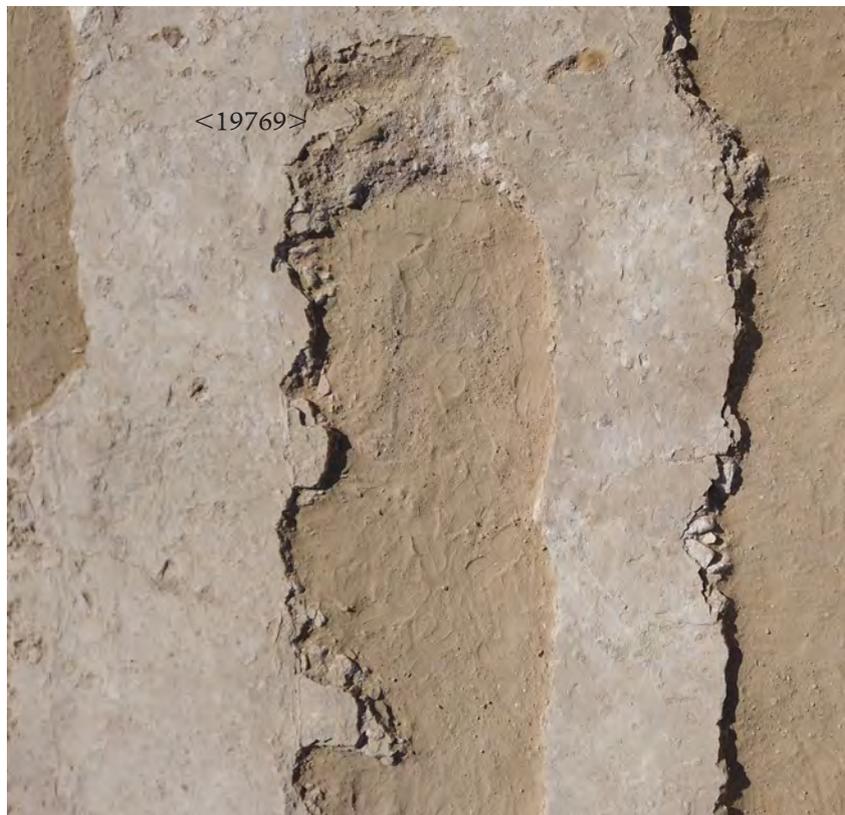
**Figure 13.** Surface of the gypsum-concrete foundation bed at the southern end of wall [19649] showing how the ancient demolition process worked. The talatat-blocks have been removed along the length of the wall. The next stage was to cut away the foundation concrete from where the wall had run. This had been done by cutting narrow trenches from side to side (probably from left to right in this picture). A pair of unfinished trenches side by side < 19769 > is at the top of the picture. South is towards the top.

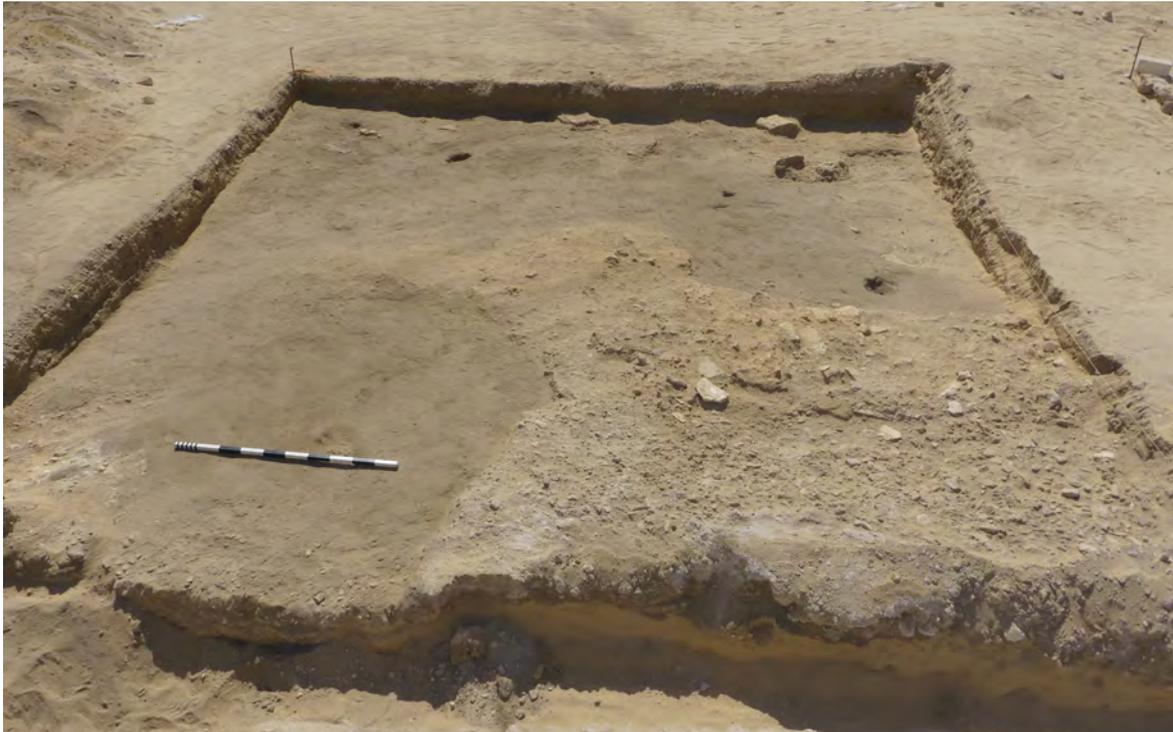
**Figure 14.** The 5 x 5 m excavation square located beside the south-east corner of the temple (Figure 10). View to the south. The underlying mud floor is visible beneath the metre scale. Part of the floor is covered with stone chippings which merge with a deposit of gypsum close to the edge of the foundation trench for the south wall of the temple.

A separate area of excavation was begun, against the southern side of the south temple wall, at the south-east corner (Figures 10, 14). This was to check if a second row of wooden posts had been erected behind and parallel to the first row and also to find out where the surface of the ground was outside the temple in the time of Akhenaten. There was not sufficient time to complete the work. What was revealed was that the original desert surface had been covered with a mud floor which sloped slightly upwards away from the temple. Part of this had been covered with a layer of stone chippings and fragments of worked stone which merged with powdery gypsum as it approached the edge of the shallow foundation trench for the temple wall at the south-east corner of the temple. A number of small, rough, rectangular limestone slabs lay scattered on the adjacent floor. An interpretation is that we are seeing an area where the gypsum concrete for the temple foundation layer was being prepared, the stone slabs being seats for the workmen involved.

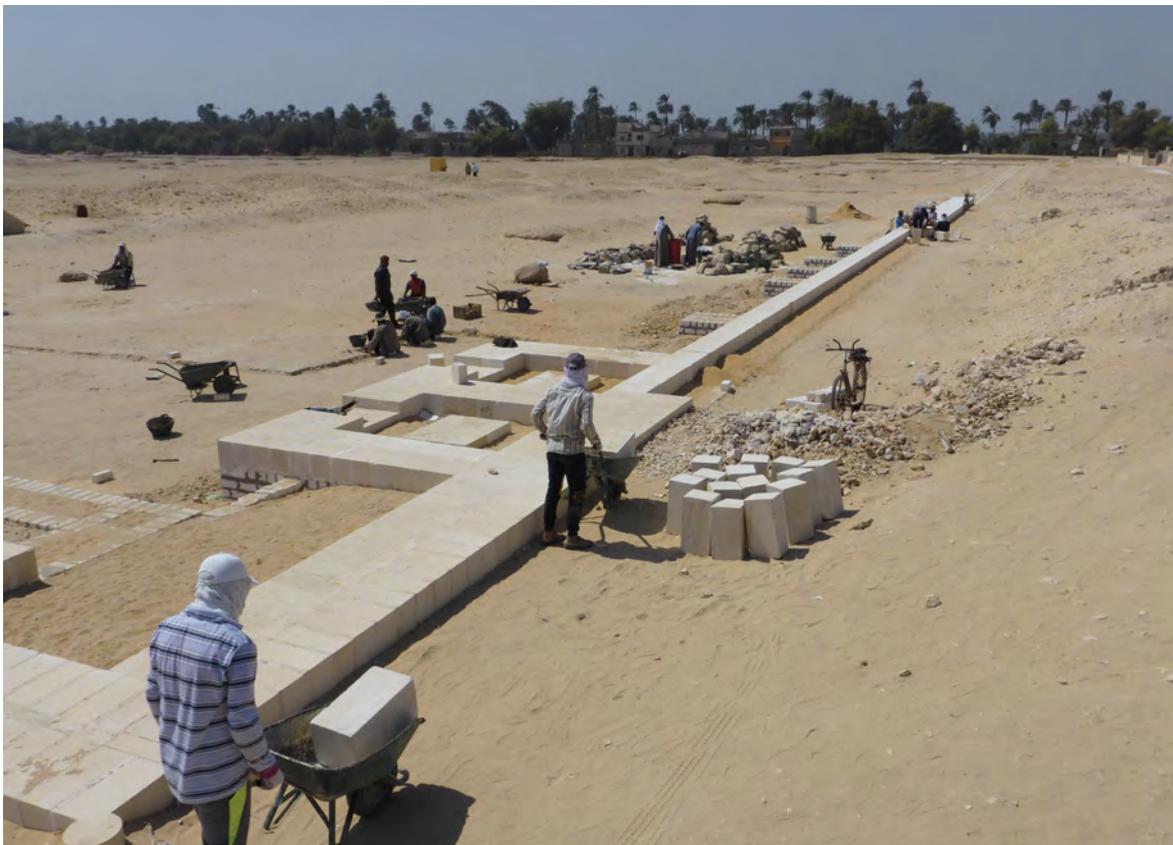
**Figure 15.** Further work of rebuilding the north wall of the temple. The lower part of the foundations, of small local limestone blocks, was completed in the spring season. Now it is being capped with the final layer of fine Tura-limestone blocks. View to the south-west.

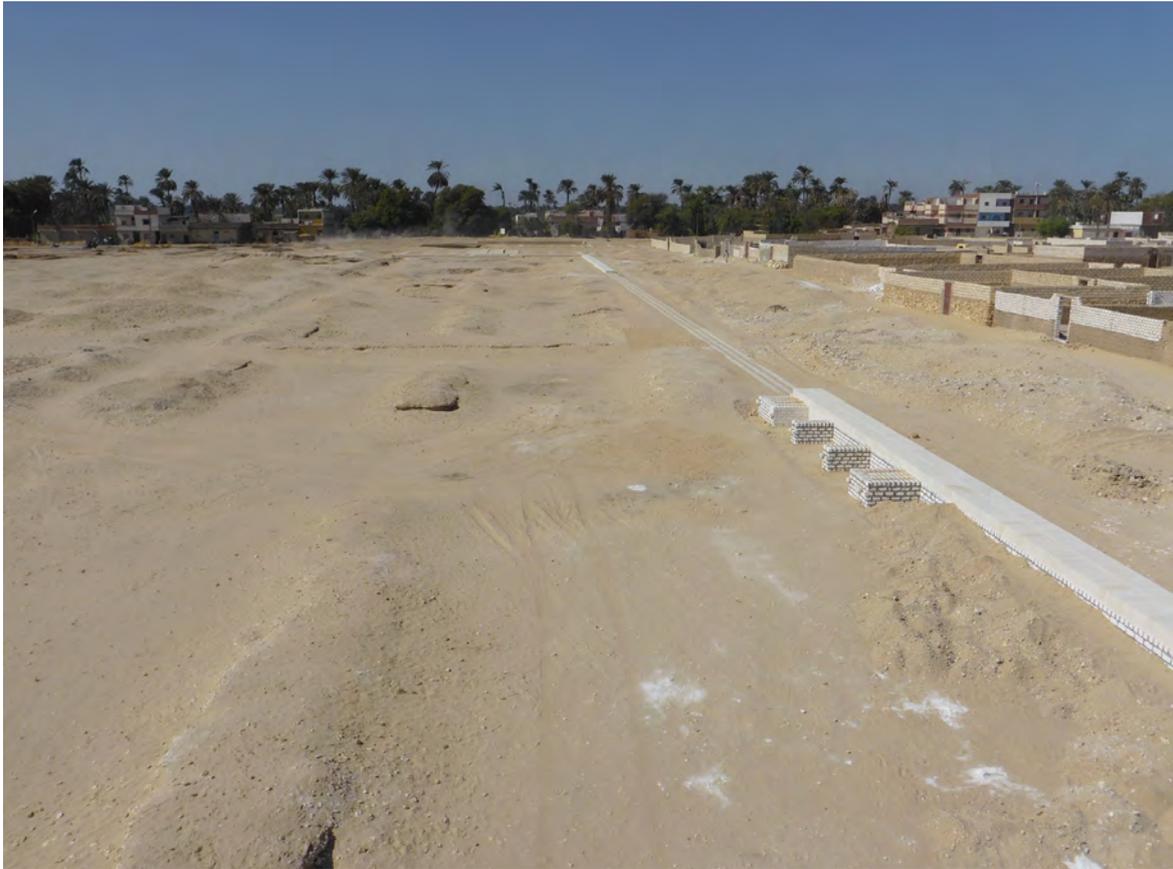
*Figure 16. The stonework of the north wall of the temple at the end of the autumn 2021 season. A section in the middle still lacks the final course of Tura-limestone blocks. View to the west.*

A delivery of 700 Tura blocks reached the site in the early summer. This number represents half of what was needed to complete the northern wall. The builders began by laying them from the eastern end of the temple and for a distance of about 64 m (Figure 16). They then moved to the front of the temple and continued to lay the remaining blocks in an eastward direction. The completion of the wall, filling the intervening space, is planned

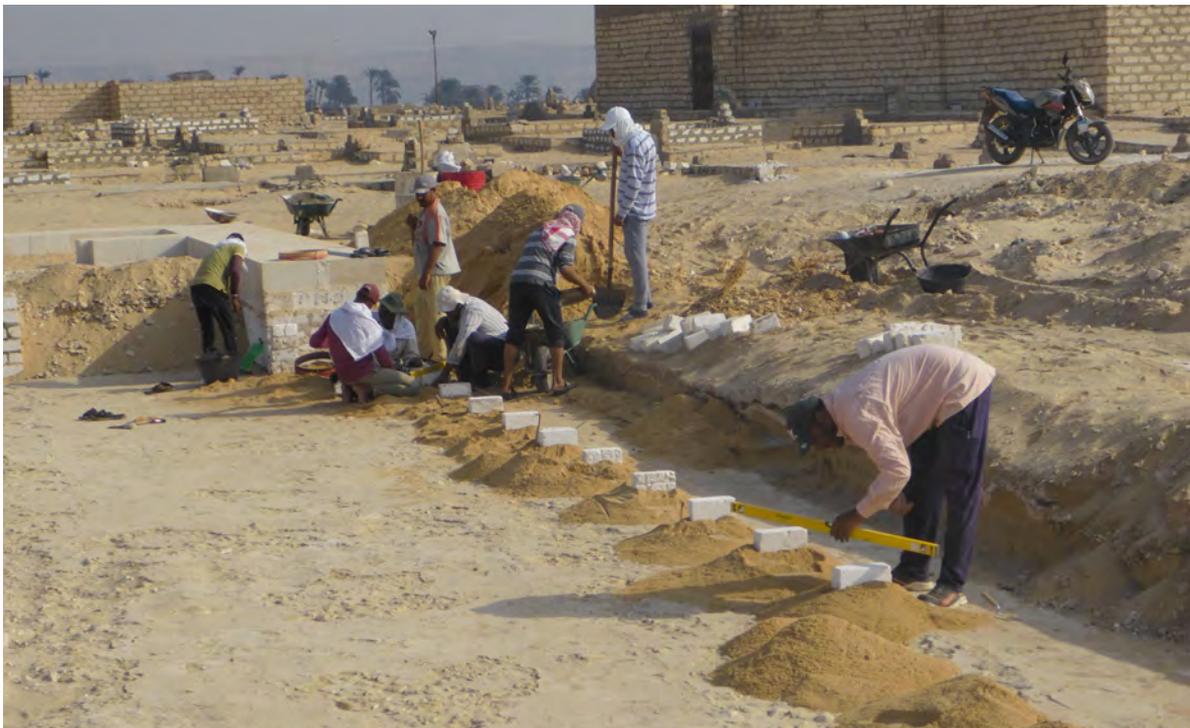
*Figure 17. At the rear of the temple the first stage of rebuilding is to set out spacing blocks on a bed of sand. View to the north.*
