British Mission to Tell el-Amarna

**Great Aten Temple  
Report on Recent Work  
(September 16th–November 4th, 2021)**

## Preliminary report on work done by the British Mission to Tell el-Amarna, September 16th–November 4th, 2021

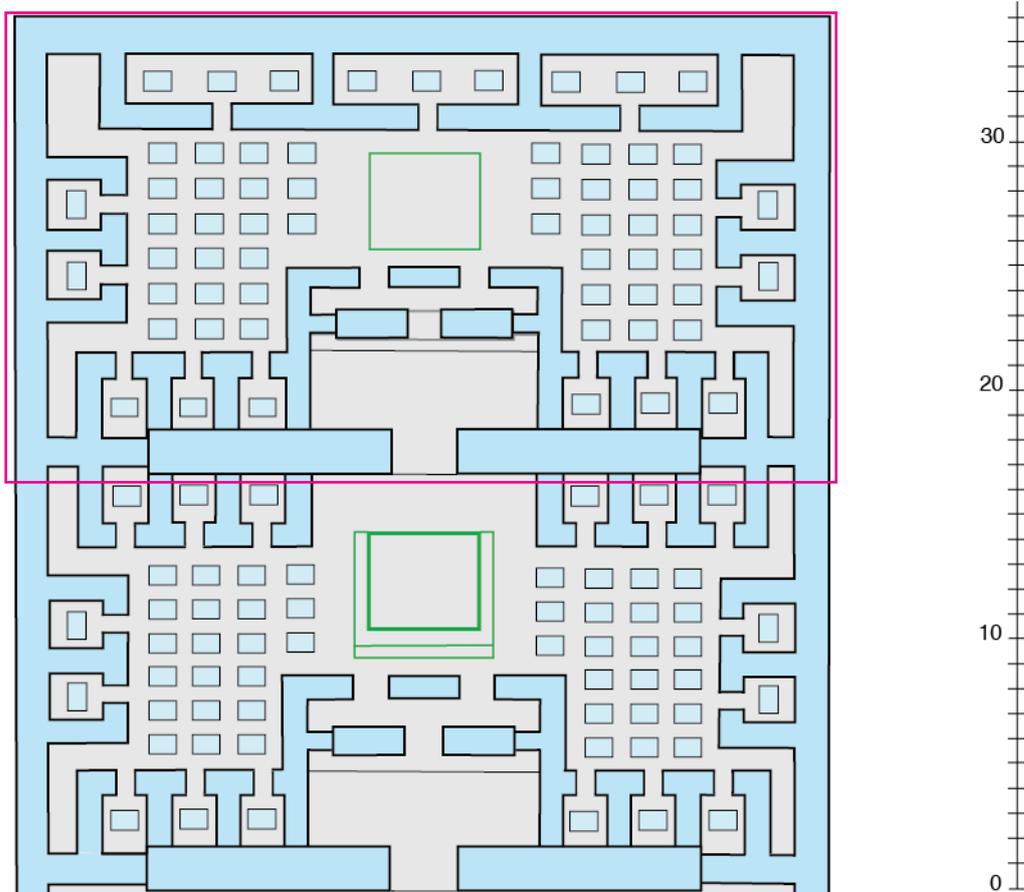
Figure 18. Reconstructed plan of the rear part of the Long Temple. The area currently being rebuilt to the height of a single course of El-Tura blocks is outlined in red.

The reconstruction of this part brings home how congested the rear of the temple must have been. In order to reach the area of the eastern main offering-table one crossed a space between a small pylon and a screen wall (in Figure 18 pierced with two doorways) which was only 87 cm wide. Yet this was the route to reach 13 small rooms each containing one or more offering-tables plus 42 unenclosed offering-tables in adjacent spaces. Was there not a regular (even daily?) need for priests and temple servants to service the total of 61 offering-tables that lay beyond this narrow space, and before that to navigate a way through the identical layout of the western main offering-table area?

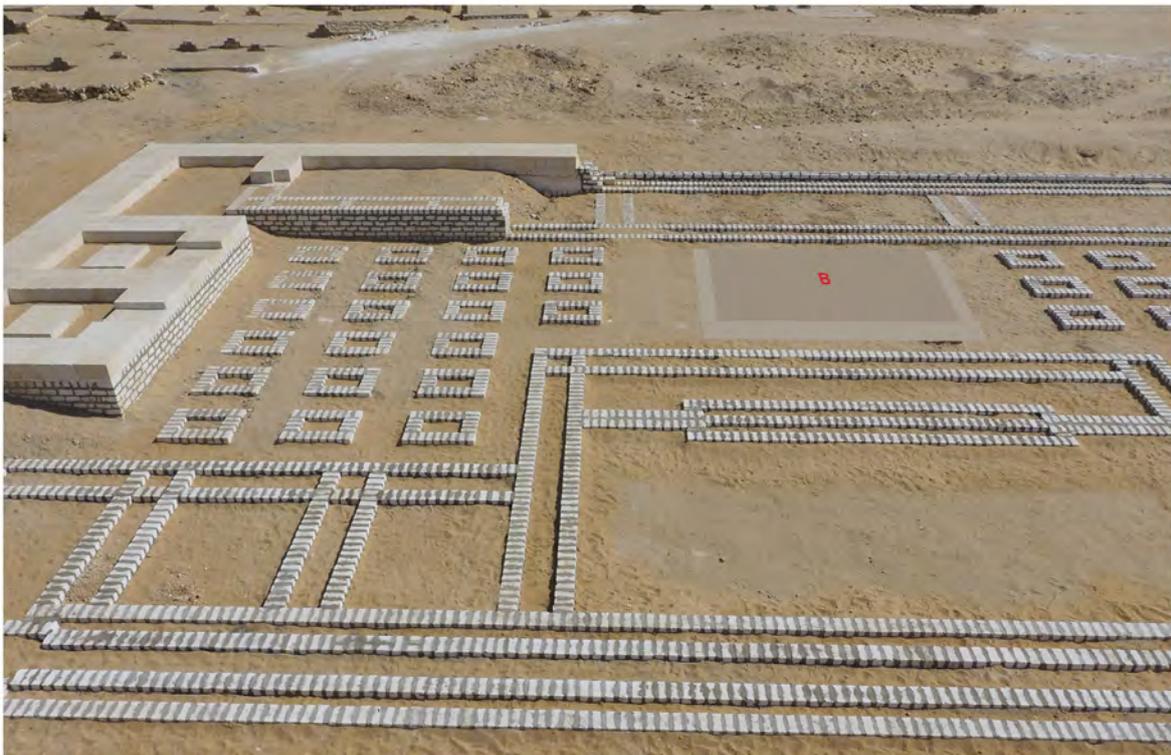
Figure 19. The rear of the temple at the end of the autumn season. View to the east. The area marked 'B' is the location of the main eastern offering-table (see Figures 6, 8 and 10). Most of the planned stonework has not yet been laid.

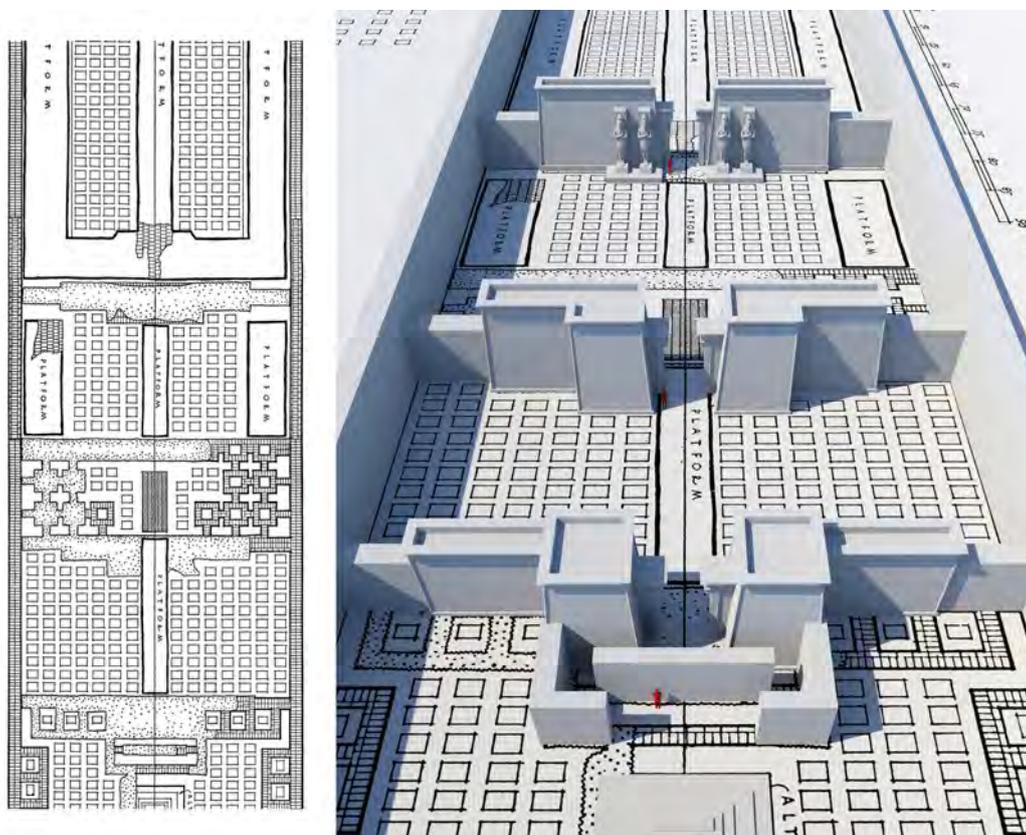
**Figure 20.** The rear of the Long Temple. Left: section of the plan by Ralph Lavers. Right: three reconstructions of the dividing walls by Paul Docherty. Furthest: simple restoration which preserves a traditional pylon form but also provides a base for statues facing sunrise; nearest: as restored by Ralph Lavers; middle: an intermediate design.

Any reconstruction, either as a drawing or as laid stone blocks, has to be based on decisions when the excavated evidence offers more than one possibility. One example is the shape of the gateways that gave access, within the temple, from one major court to another. The gateways were evidently in the centre of the walls that crossed the temple from north to south. The central portion was thicker, implying the presence of a pair of pylons, but a second thickness was added on the inner (eastern) side, giving rise to reconstructions (starting with those of Ralph Lavers) which gave an L-shaped plan and perhaps extra height to the inner sections of the ‘L’. In Figure 20

the reconstruction of one of the three gateways has been made simpler, by keeping to a pair of rectangular pylons. This leaves the deep paved space on the east side without a clear function, however, although statues could have been set up on the north and south walls facing inwards towards the temple axis or even eastwards towards the sunrise (as in Figure 20, the furthest doorway).

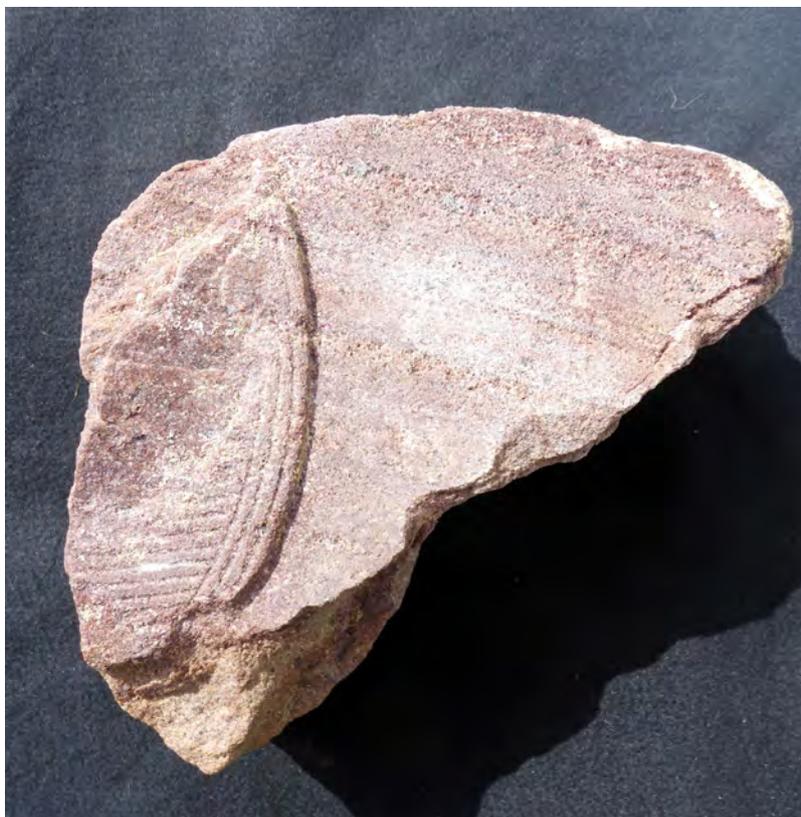
*Figure 21. Part of an almost lifesize quartzite statue: base with fragment of sandal (S-16093). Length 18 cm.*

The clearing of the c. 10 cm-thick overburden of sand at the gypsum-concrete foundation of the Long Temple in preparation for its re-planning and re-building with fresh stonework produced altogether 14 trays of stone fragments, namely: 10 trays of limestone fragments, 1 tray of quartzite fragments, including the sandal from a statue (Figure 21), inlays of various stone and one faience tile with a papyrus plant motive (Figure 22), 2 trays of granite/granodiorite fragments and 1 tray containing sandstone, indurated limestone and alabaster fragments. Another tray contained small finds and gypsum fillers as well as a sample of splashes of paint on gypsum taken from the foundation surface.

The statue fragment of a sandal (fragment S-16093, Figure 21) (all trace of the actual foot having been carefully removed), was recovered from within the sand close to the side of the place where the eastern main offering-table

had stood (pit <19551), all traces of the foundations for the offering-table having been destroyed in the aftermath of the Amarna Period. The fragment is likely to have lain below the level reached by Pendlebury's workmen and so could have come from a statue that had stood close by.

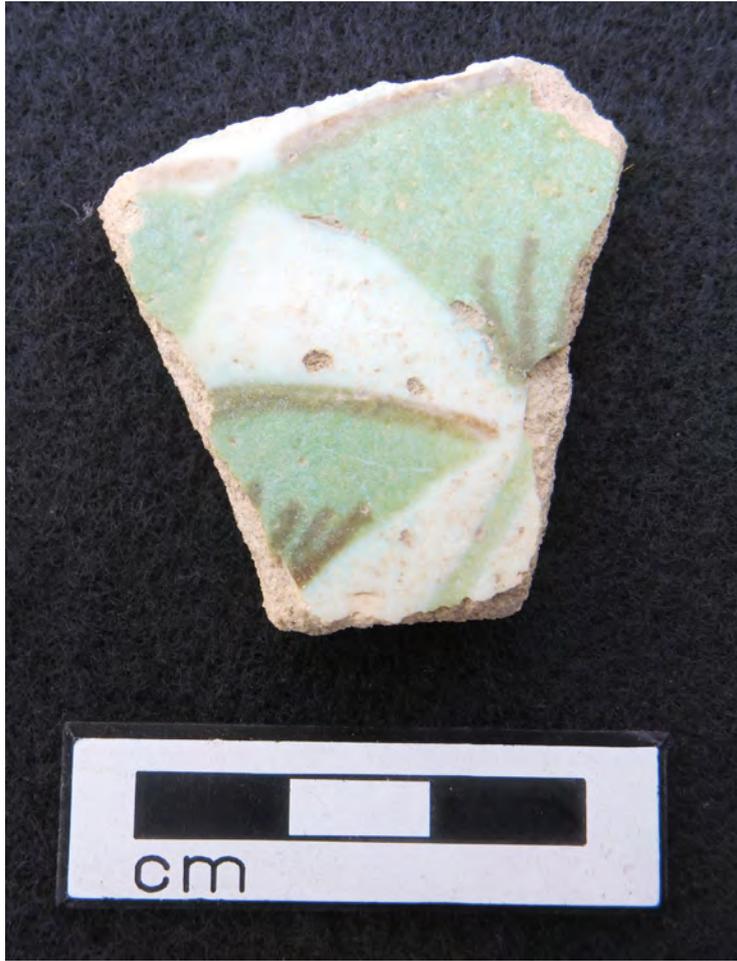
Figure 22. Obj. 43720. Faience tile with papyrus motif.

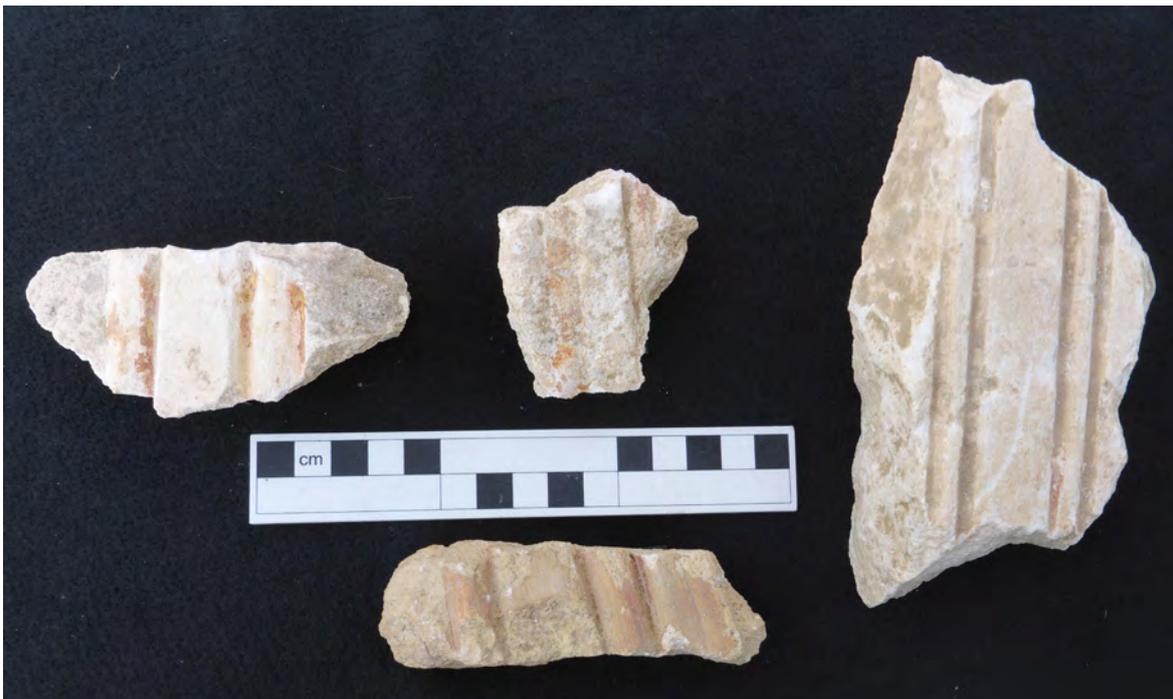
Figure 23. Fragments of limestone relief showing some of the different styles of Aten rays.

In contrast to the first four courts of the Long Temple, which contained rows of limestone offering-tables only, the last two contained also a number of small chambers with either a single offering-table or a maximum of three. They were surrounded by walls which were 1.5 *talatat*-blocks wide (Figures 2, 10). This season and the spring season of this year, which concentrated on the northern wall of the Long Temple in this area, produced numerous limestone fragments with Aten rays that differ in size, width, spacing and colour (Figure 23) and many gypsum patches made to fill gaps between blocks, as if the interior walls were decorated by different artists, which seems likely if one takes the short period of time into account in which the Long Temple was built. Since the entire layout of the Great Aten Temple was open to the sky, the reliefs inside the chambers would have been visible all day, especially at mid-day, without additional lighting, each crowned by an individual scene of the Aten and its downreaching rays.

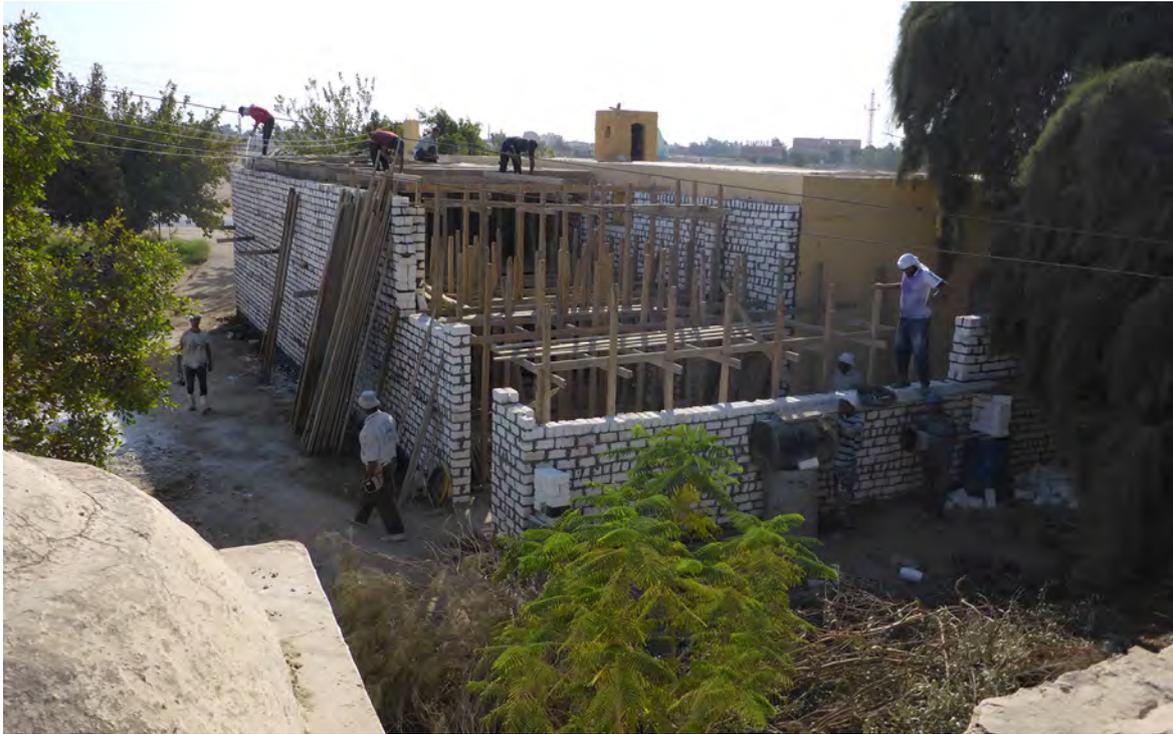
*Figure 24. The new magazine extension under construction. View to the south.*

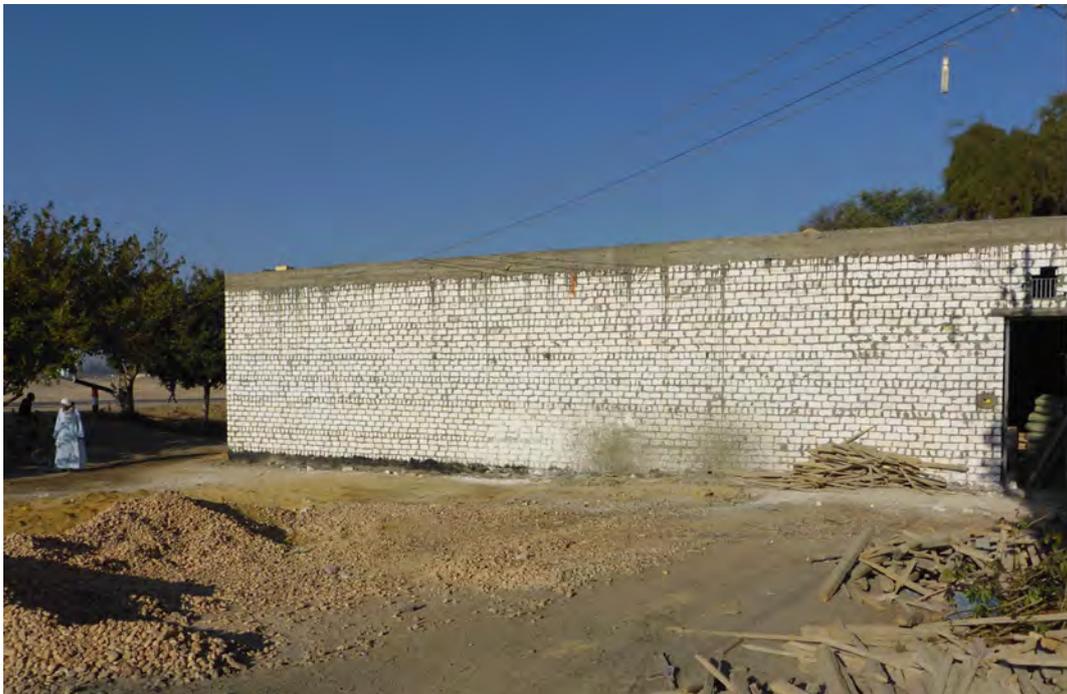
*Figure 25. The new magazine extension as partly built. View to the west.*
